XY Route – Earth Wire Fall To Ground During 275kV OHL Refurbishment

An incident occurred on site where an earthwire came to ground on Saturday 25th June 2016 between the sections at towers XY43 and XY46 and XY47.

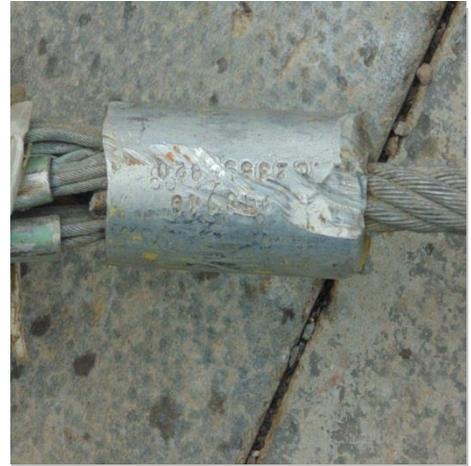
- This “shunting” procedure or situation is not stated or covered in the AFW RAMS nor was it approved by SPEN.
- In all probability, the incident occurred by the movement of the earthwire with a TEB attached and the unintended accelerated movement of conductor caused by the ferrule of the conductor stockings sticking in the running out wheel whilst being shunted from XY47

- The sudden release of the stocking caused the conductor to run and the TEB to hit the running out wheel, resulting in the TEB with its associated clamp damaging the outer strands of the conductor. This resulted in the stocking separating from the earthwire which came to ground in an uncontrolled manner.

Damaged Ferrule on Stocking

- Tandem blocks to be used on angles greater than 30deg for earthwire installation
- Sidewinder earths at angle situations to be introduced
- Contractor to investigate their own training methods in relation to shunting and TEB removal
- Contractor to review pre-pull check sheet
- Safety stand-down to be held with contractor overhead gang to reinforce any deviation or change from approved procedures & documentation must be challenged back to site management (behavioural)
- Contractor to review RAMS for earthing of phase & earthwire
- Contractor to review RAMS for replacement of Lynx E/W with Keziah OPGW
- SPEN to review its position on the shunting method. Until this is reviewed the use of shunting on SP network is expressly forbidden unless agreed under a special procedure

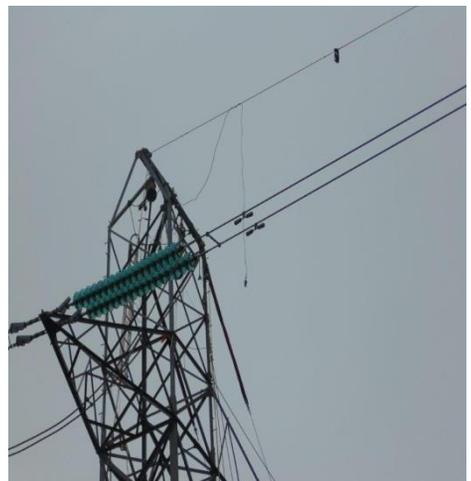
As part of the construction methodology, protection scaffolds and “Cass” systems were utilised in a number of sections including between XY44 & XY45. As a result of the protection measures the earthwire was captured in the section XY45 and XY44 and prevented the earthwire coming to ground.

Attached earthwire on Tower XY45 on Tower XY44 side
