SHE ALERT

ELECTRICAL FLASHOVER TO SWITCHBOARD INCOMER 415v CIRCUIT BREAKER – NON SSE RELATED

Fire: F9782/9628

Fire Title	Electrical Flashover on U2 Boiler / Turbine Services Switchboard 2A
Occurred	Fri 17 Jul 2015 17:09
Business Unit	./Eggborough
Fire Location	Eggborough
Site Area	Internal Plant Area - U1 / U2 28ft Boiler House Switchroom
Plant Item	Unit 2
Details	Electrical flashover occurred on switchboard incomer 415v ACB whilst re-energizing switchboard. Small amount of sparks / flames / smoke witnessed expelling from switchgear. Sparks / Flames rapidly extinguished themselves without intervention. No casualties or injuries incurred.
Immediate Actions	Incident alarm raised and IRT deployed. Fire Brigade called to site. Station IRT and Fire Brigade checked for evidence of heat / fire and non present, hence, no fire extinguishers or water was necessary. Switchroom purged of residual smoke. Switchboard isolated and made safe.

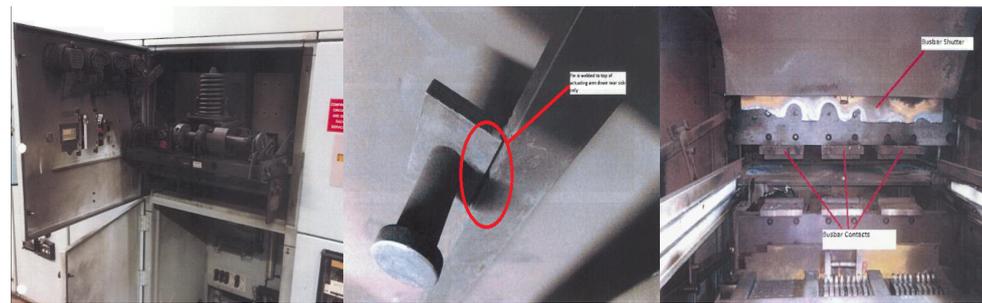
An electrical flashover occurred at a non-SSE Power Station which involved a 415 volt switchboard ACB (see external report below for further details). Whilst re-energising the switchboard a flashover occurred causing an ejection of sparks and flames to exit the cubicle. The switchboard Incomer ACB door was fully closed and secured resulting in the cubicle containing the flashover and venting out the vents at the rear of the cubicle as it is designed to do in the event of such a fault, i.e. away from any personnel in front of the switchboard. No injuries occurred.

The investigation found that the flashover was caused by the busbar shutters on the 415v ACB cubicle not being fully opened when the ACB was racked in. The reason for the busbar shutters not opening fully was that the shutter lifting pins had become bent. The investigation concluded that the pins would only become bent if the shutter linkage was prevented from moving when the ACB was pushed into the service position. For this to occur, either the shutter or shutter operating mechanism was jammed in some way, or it could have been due to an isolation lock being inadvertently left on when attempting to insert the ACB. Further inspections of the pins identified that they were only welded to the actuation arm on one side rather than on both sides which allowed the pins to bend more easily.

- Provide a suitable maintenance schedule to adequately maintain switchgear
- Check the integrity of busbar pins for fatigue or cracking and implement repairs if necessary

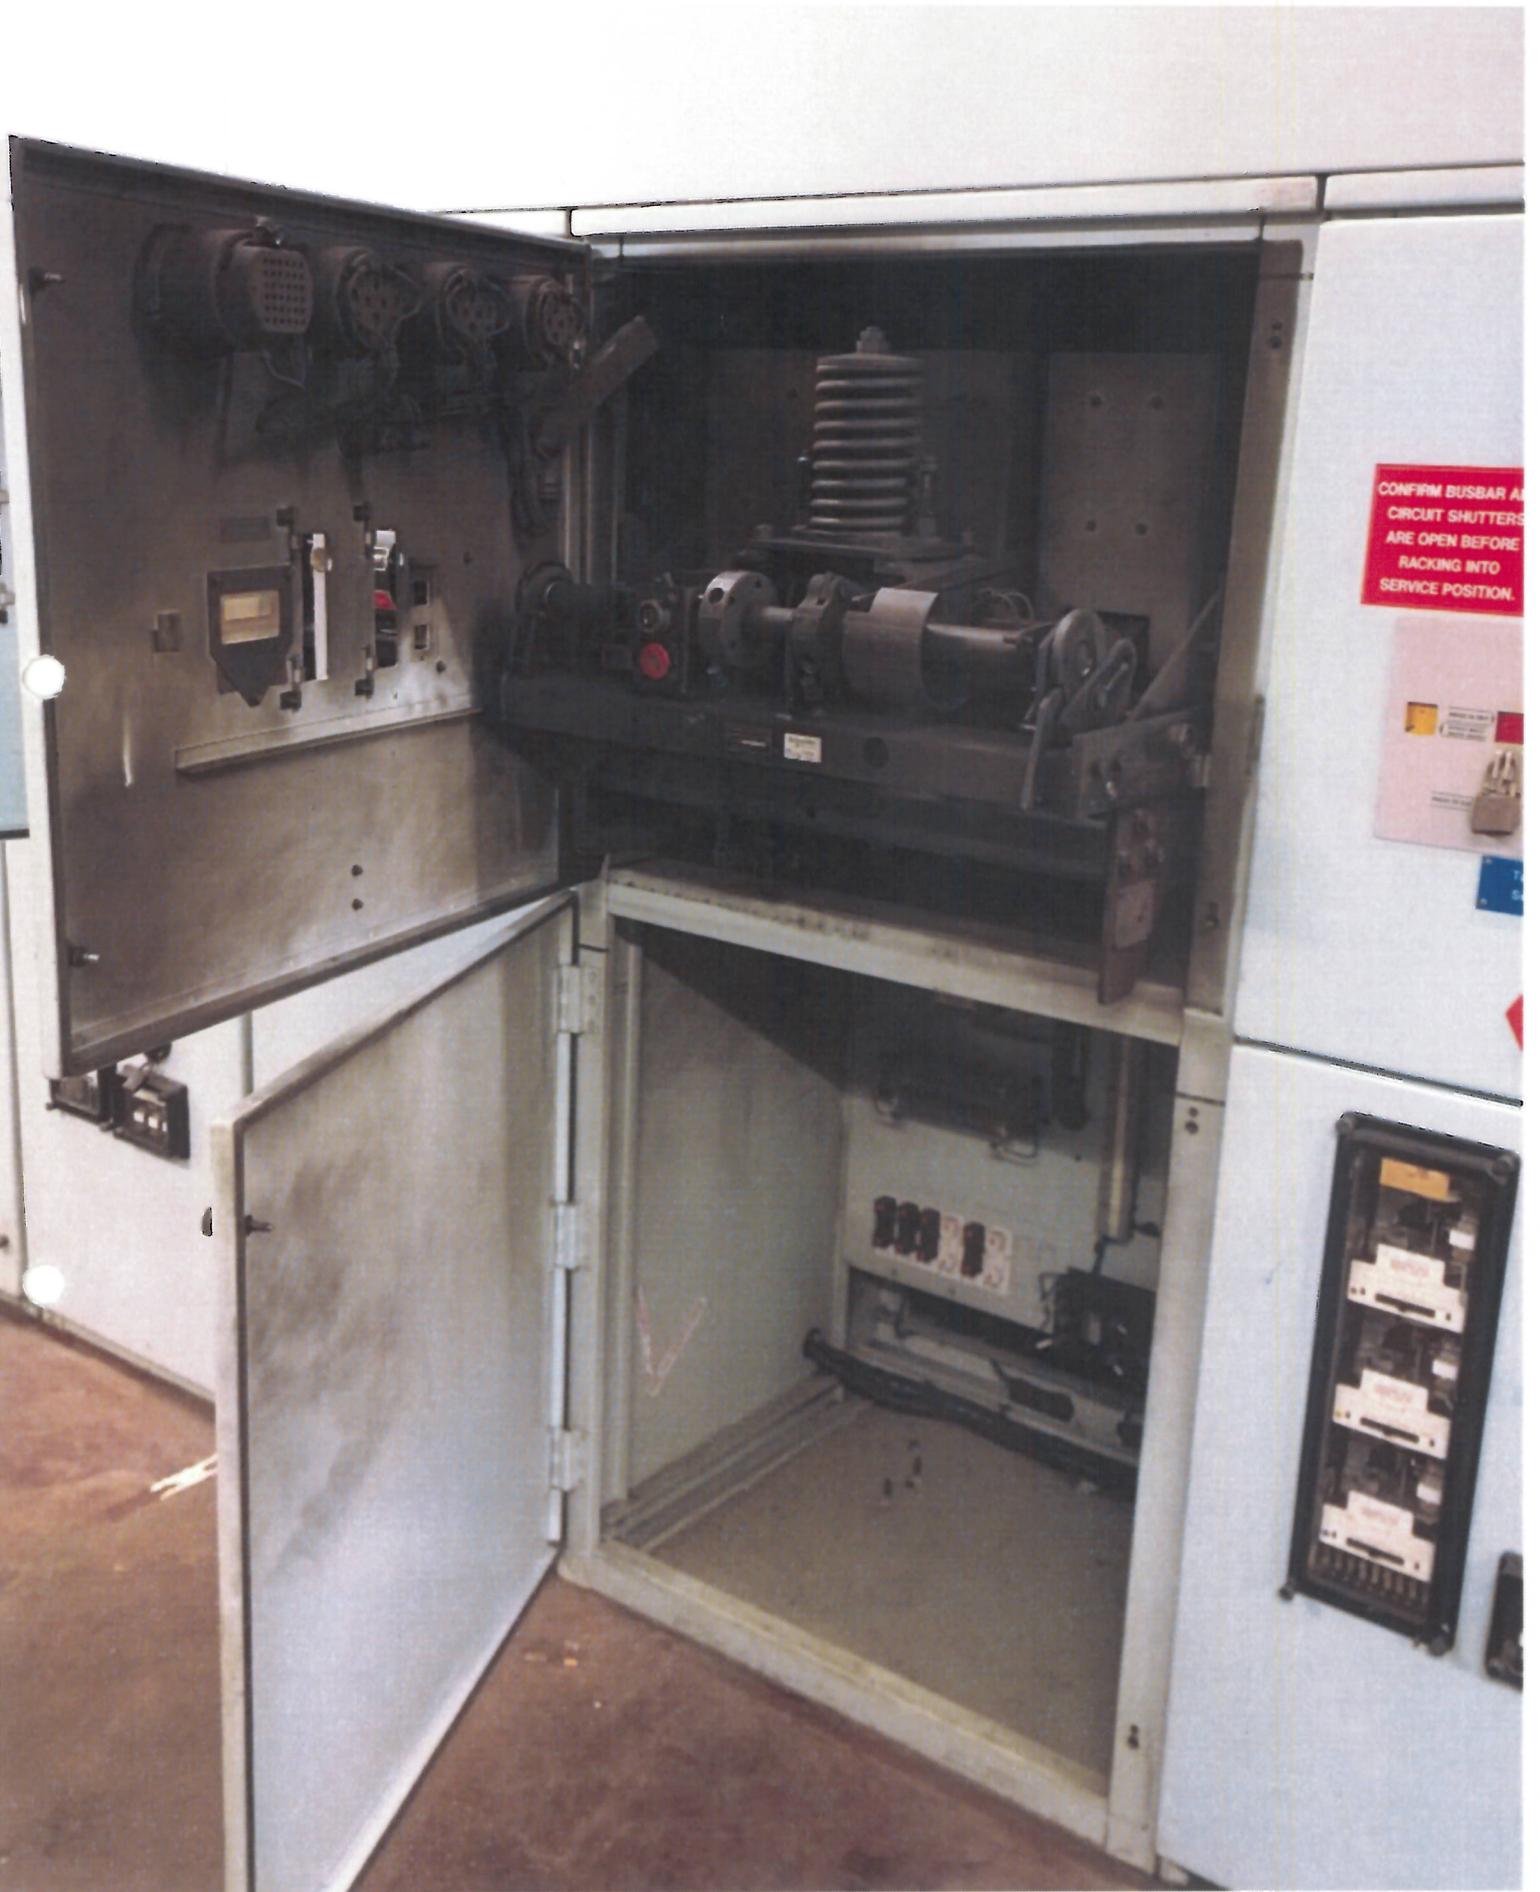
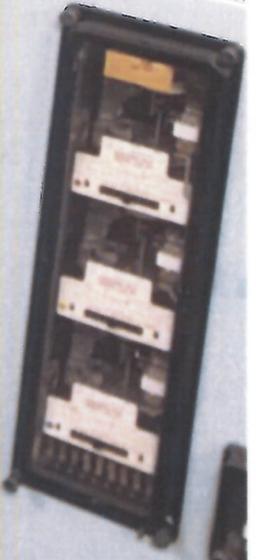
CONFIRM BUSBAR AND
CIRCUIT SHUTTERS
ARE OPEN BEFORE
RACKING INTO
SERVICE POSITION.

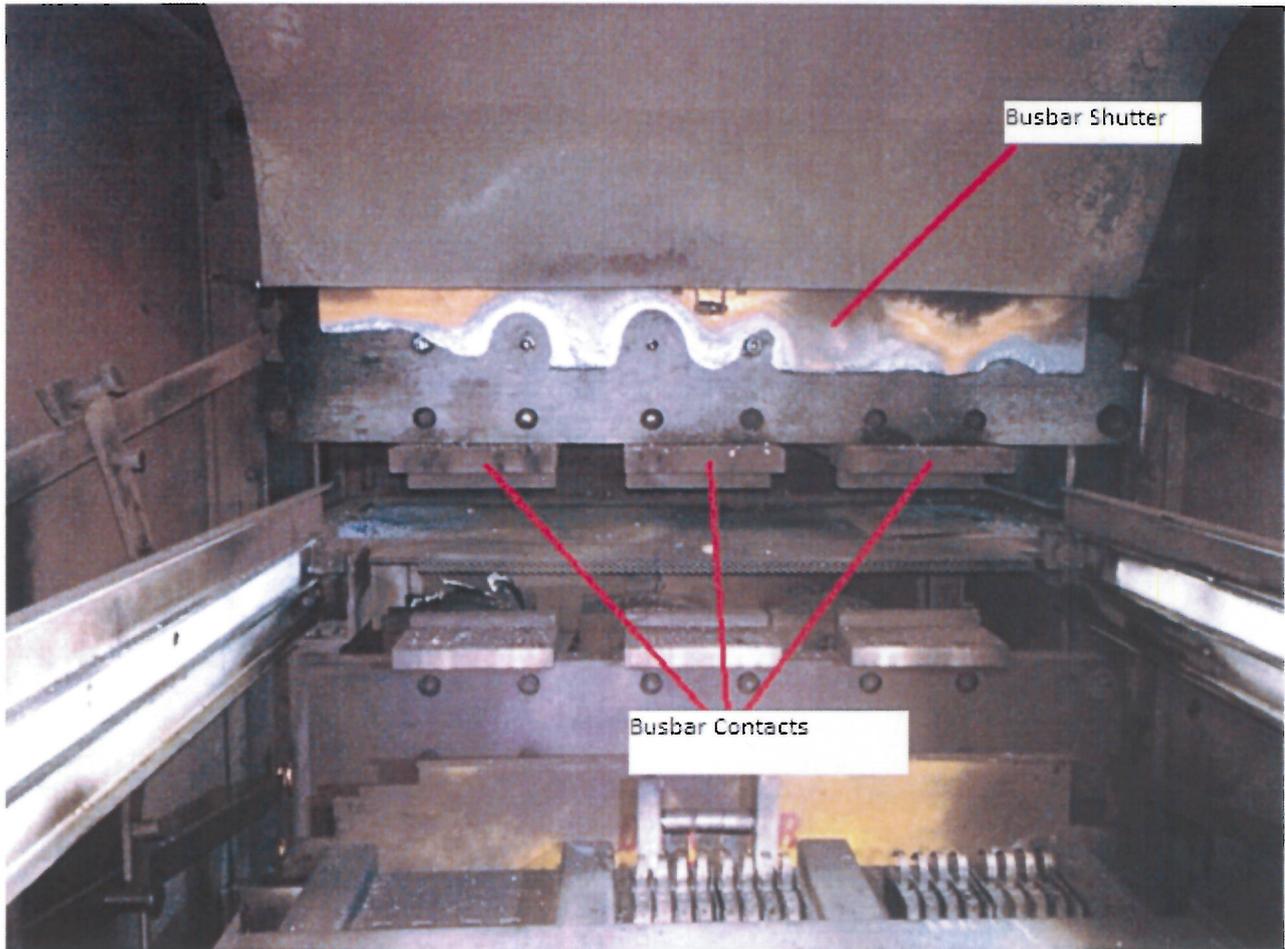
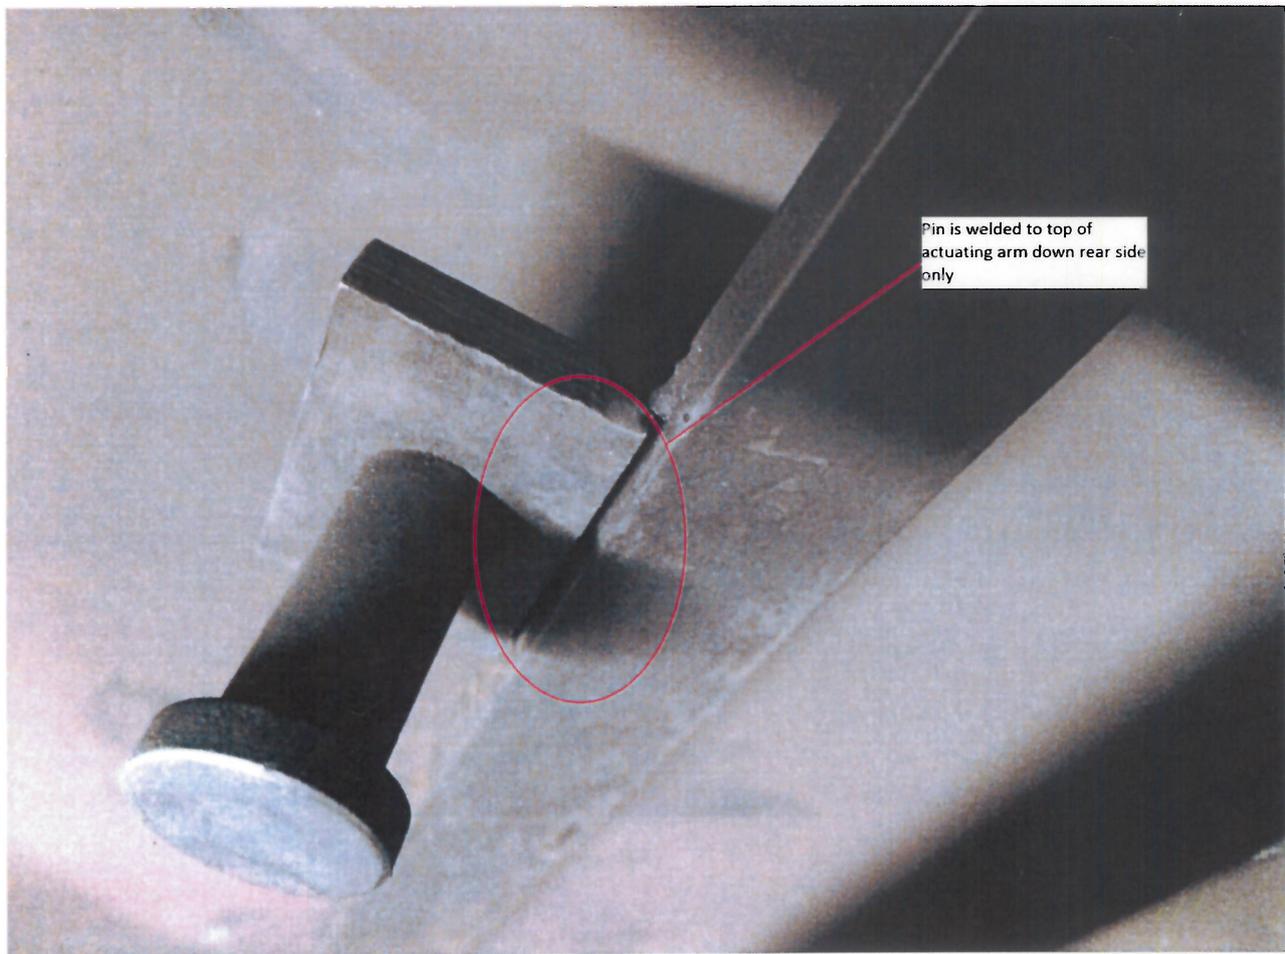
Contributing Cause	Job Factors - Depreciation of equipment
Other Cause	
Investigation Findings	Investigation has shown that the flashover was caused by the busbar shutters on the 415v Boiler / Turbine Services Switchboard 2A Incomer ACB not being fully opened when the ACB was racked on. This resulted in a 3 phase flashover when the circuit was subsequently energized by remotely closing the 11kV ACB on the 11kv to 415v Boiler Turbine Services Transformer 2A. It is important to note that 415v Boiler / Turbine Services Switchboard 2A Incomer ACB door was fully closed and the securing screws were fully tightened down. This resulted in the switchgear cubicle containing the flashover and venting out of the vents at the rear of the cubicle as it is designed to do in the event of such a fault i.e. away from any personnel in front of the switchboard.

Action	<p>Generate PDA for Operations Safety Controllers staff to be briefed on:-1 Summary of the investigation of the incident2 Requirement to check shutter operating pins for damage prior to putting 415v ACBs into the service position. Also check that all points of isolation locks have been removed. 3 When putting the ACB into the service position, check that the busbar and shutter operating mechanism operates.4 Checking, as far as is practicable, that once the ACB is in the service position that the busbar and circuit shutters have opened fully and that the operating pins have not become bent / damaged.5 Emphasise the importance of ensuring all panel doors are FULLY secured when de isolating and returning switchgear to service in order for any fault which may occur to be contained within the switchgear.6 Reiterate the importance of carrying out switching activities remotely or on to de energised circuits whenever possible.Generate PDA on E,C&I Maintenance Electrical Engineer to brief E,C&I Maintenance teams on:-1 Summary of the investigation of the incident2 Requirement to check shutter operating pins for damage when carrying out ACB and cubicle maintenance and specifically prior to returning a ACB to the cubicle following maintenance.3 Emphasise the importance of ensuring all panel doors are FULLY secured after carrying out maintenance on switchgear in order for any fault which may occur to be contained within the switchgear.Generate a PDA on the Electrical Engineering Technical Engineer to:-Carefully review the design of the attachment of the busbar shutter operating linkage pins and make recommendations on any modifications, if appropriate, which would reduce the likelihood of a repeat incident. Also to recommend timescale and process for carrying out such modifications.</p>
