JOINTER RECEIVED BURNS AFTER FLASHOVER ON LV CABLE GREAT GEORGE STREET GLASGOW

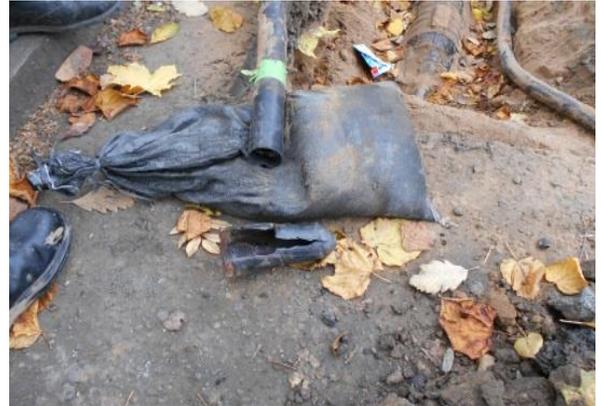
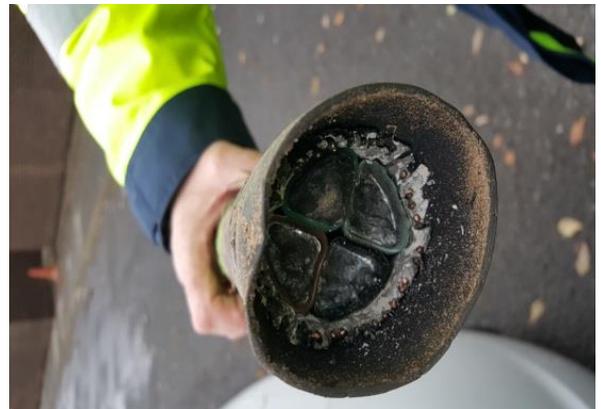
On October 27th 2016, an SPD cable jointer sustained injury to his face and neck via a flashover from an LV 240(4) waveform cable when carrying out works testing LV cables in preparation for new connection. Whilst executing the works a cable with a capped end was found. The jointer removed the cap and a disruptive failure then occurred.

- When working with underground cables treat all cables as “live” as per [PSSI 12](#) Section 12.1.1
- When testing to determine whether a cable is “live” or “not live”, carry out tests a minimum of 1.5m back from any capped or damaged end
- Never bury capped cables
- Importance of ensuring cable records are accurate and updated
