UNIMOG BOND FAILURE

WHAT HAS HAPPENED?

Emergency recovery work was being carried out on the 4YX route following the parting of some Brown Porcelain insulators.

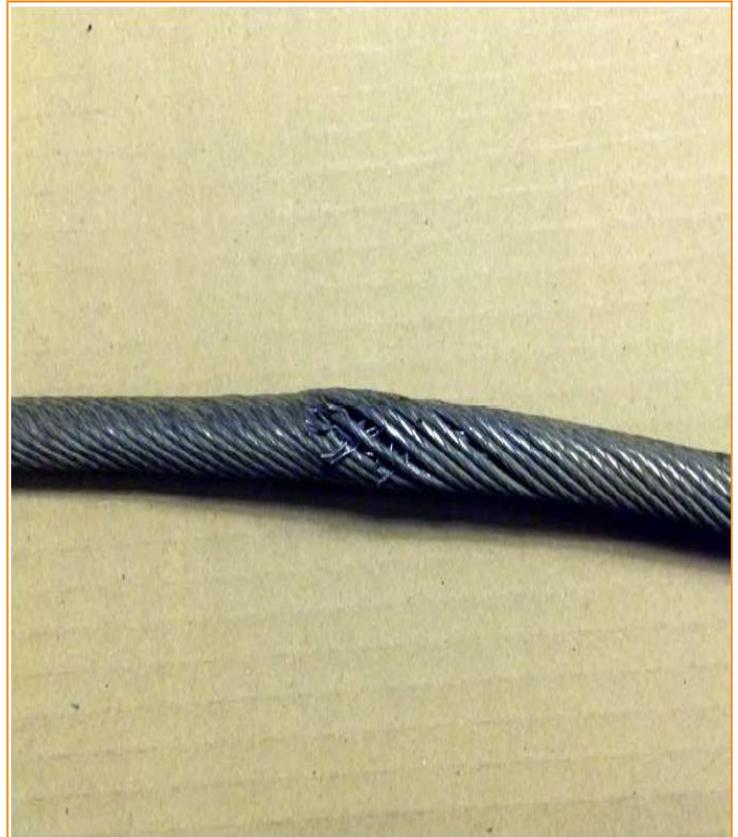
During a standard winching operation, the inner strands of the winch bond sheared shaking the tower arms and causing a loud noise. This resulted in the load being held purely by the outer strands.

- Investigation of the incident has determined that all the Unimog winch bonds have a minimum bending radius of 280mm (11"), but are being used with 10" and 4" blocks. This is likely to have resulted in significant fatigue of the bond such that major failure has occurred.
- Further investigation of other Unimog winch bonds have confirmed similar fatigue.

- ETAM OHL Managers shall ensure the action below;
- Stop use of all Unimogs with immediate effect.
- Review all other winches to ensure suitability with our operations.
- 4 Unimogs (2 North, 2 South) to be re-wired and ready for use by the end of the month under a new temporary procedure.
- Review initial specification of equipment to determine fitness for purpose.
- Temporary hire replacements to be sought for use in an emergency until the end of the month.
