# Safety Bulletin No. 3/2015

## FLASHOVER IN TEMPORARY DENSO JOINT

Issue date	04 June 2015
Issued by	Vincent Cranny
Applicable to	Craftspeople and Engineers

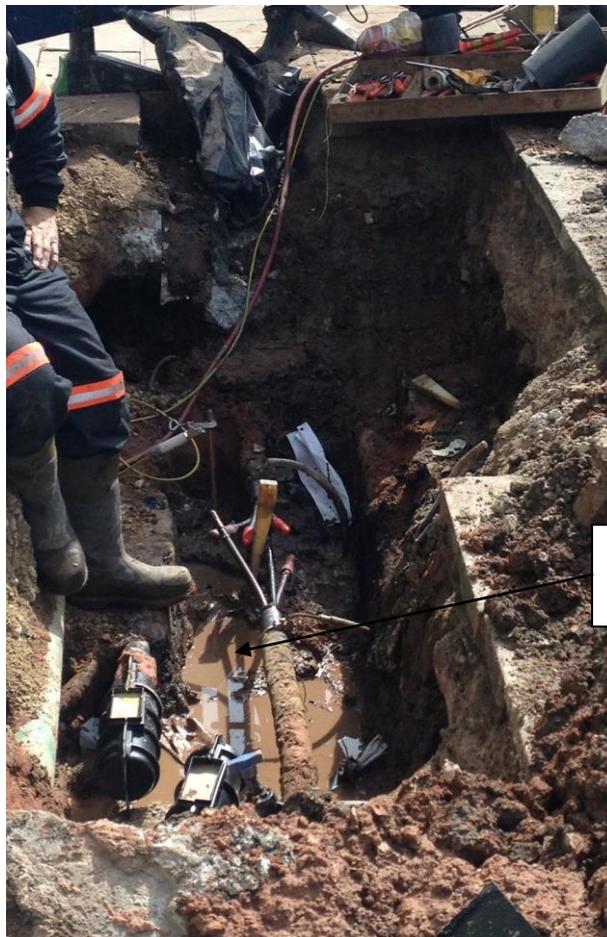
This cable had faulted the previous night and an excavation had been prepared and the cable had been cut and a temporary Denso joint had been fitted approximately 15m from the fault location. As the Apprentice stood on the cable in the excavation approximately 750mm from the Denso joint a flashover occurred within the Denso joint.

Point cable was stood on.

- Cables and other utility equipment should not be used as steps when entering or leaving excavations.
- When applying insulation patch ensure no sharp part of the conductor can pierce the insulating patch.
