Site Flooring Removed

This Safety Express was sent to ScottishPower from Scottish Water it highlights hazards relating to unauthorised removal of flooring at one of their redundant assets.

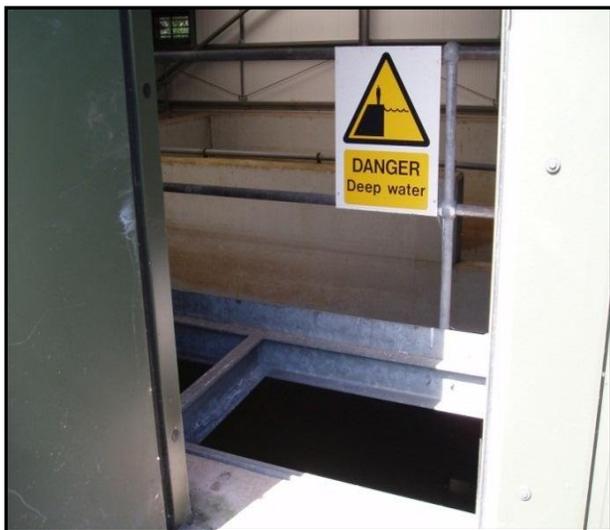
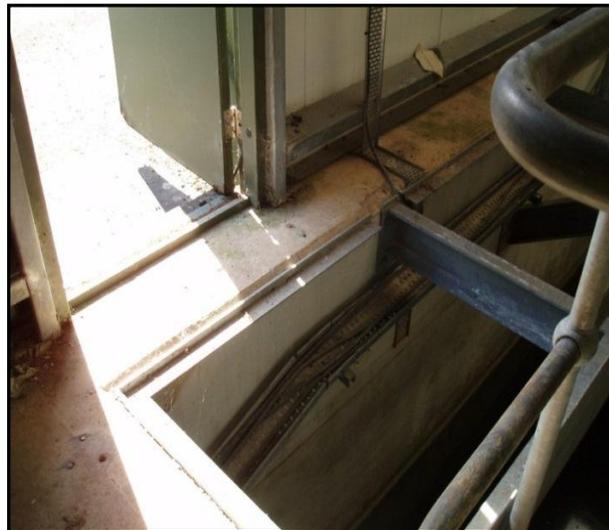
Scottish Water staff working as part of the Redundant Asset Group discovered that two steel 1.5m x 1m sections of internal flooring had been removed from just inside the access door, exposing those accessing the site to a 5m fall into a concrete tank. Further investigation identified that a number of other sections of flooring had been removed throughout the site all without authorisation, by persons unknown. As a result, a number of serious fall from height hazards were created.

Arrangements were then made to cover all openings with strong wooden sheeting suitably secured.
