Suspension of Operational Practice Hawker Siddeley Falcon RMU - SOP 400

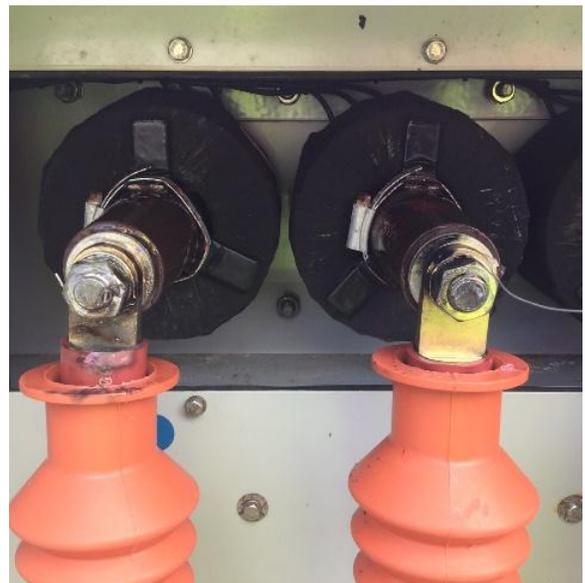
This occurred during a switching operation from the Earth ON to the OFF position during testing from the circuit breaker in preparation for a transformer change. A strand of binding wire had been connected across all three phases in the cable box in preparation for a pressure test. This strand burned off (lower photo) during the switching operation described.

The possibility for mechanism over-travel in switching the circuit breaker to the OFF position could affect any of the Falcon RMUs on the SPEN network.

The cause, and possible solutions, are currently under investigation with Hawker Siddeley Switchgear.

- For all Hawker Siddeley Falcon RMUs there shall be no manual operation of the RMU circuit breaker while the busbars are live.
- Operating “not live” can be achieved by opening both RMU switches – it is not necessary to isolate from remote locations.
