FOR ISSUE TO LIGHTING SERVICES, CONTRACTING & NETWORKS

SHE ALERT

VERSALIFT MEWP

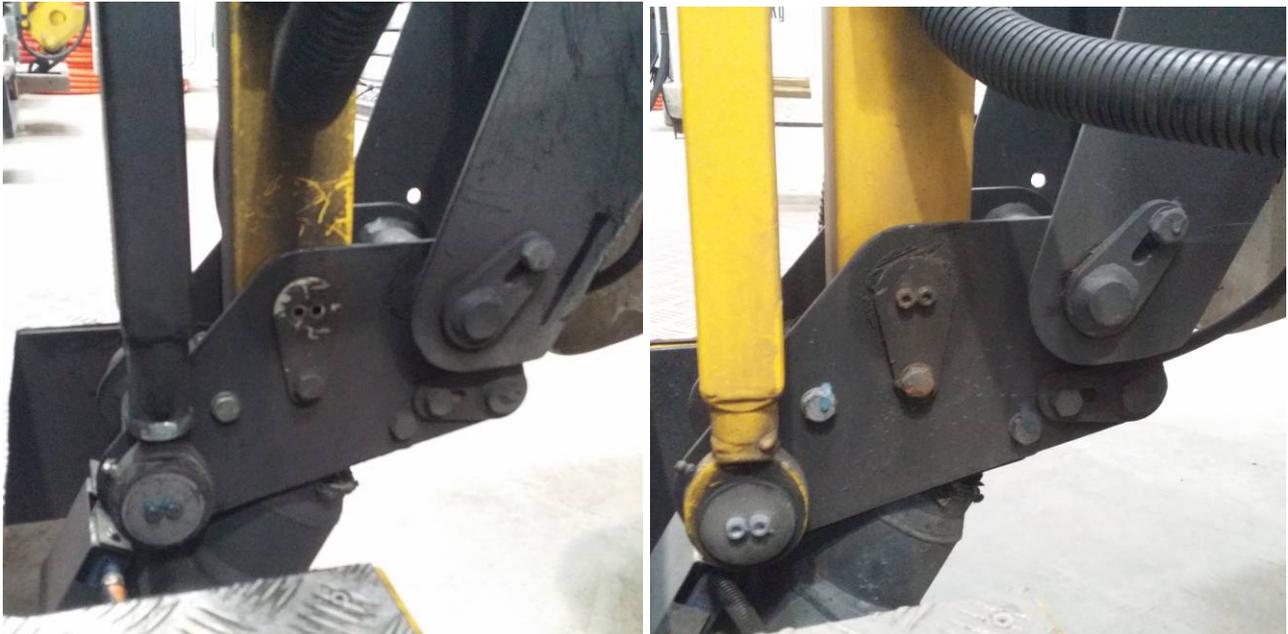
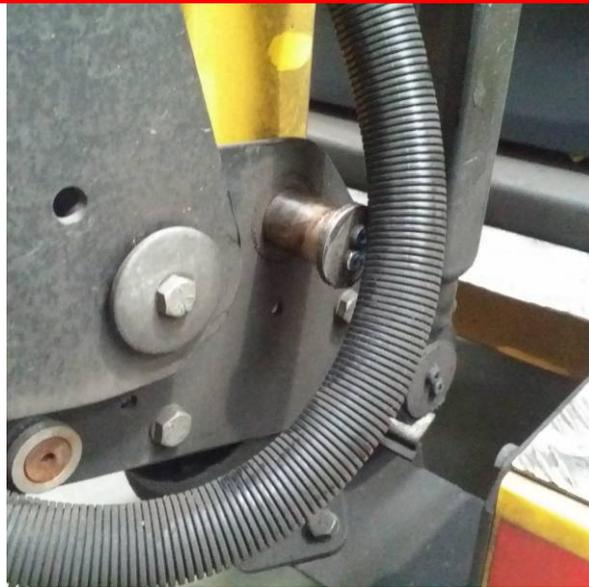
During a visual inspection at the start of his shift our colleague noticed that the cage pivot pin holding the fly boom to the bucket was protruding approximately 60mm out from its sleeve.

On further inspection it was found that the two allen screws that secure the pin were missing. This allowed the bucket to twist on the end of the fly boom. The vehicle was removed from service immediately and the defect reported.

All Versalift MEWP's must be visually inspected to ensure this pin isn't protruding and the allen screws that secure it are in place. If they are loose or missing the MEWP MUST NOT be used until LEX have effected a repair.
