SHE ALERT

Avon Road Substation Flashover

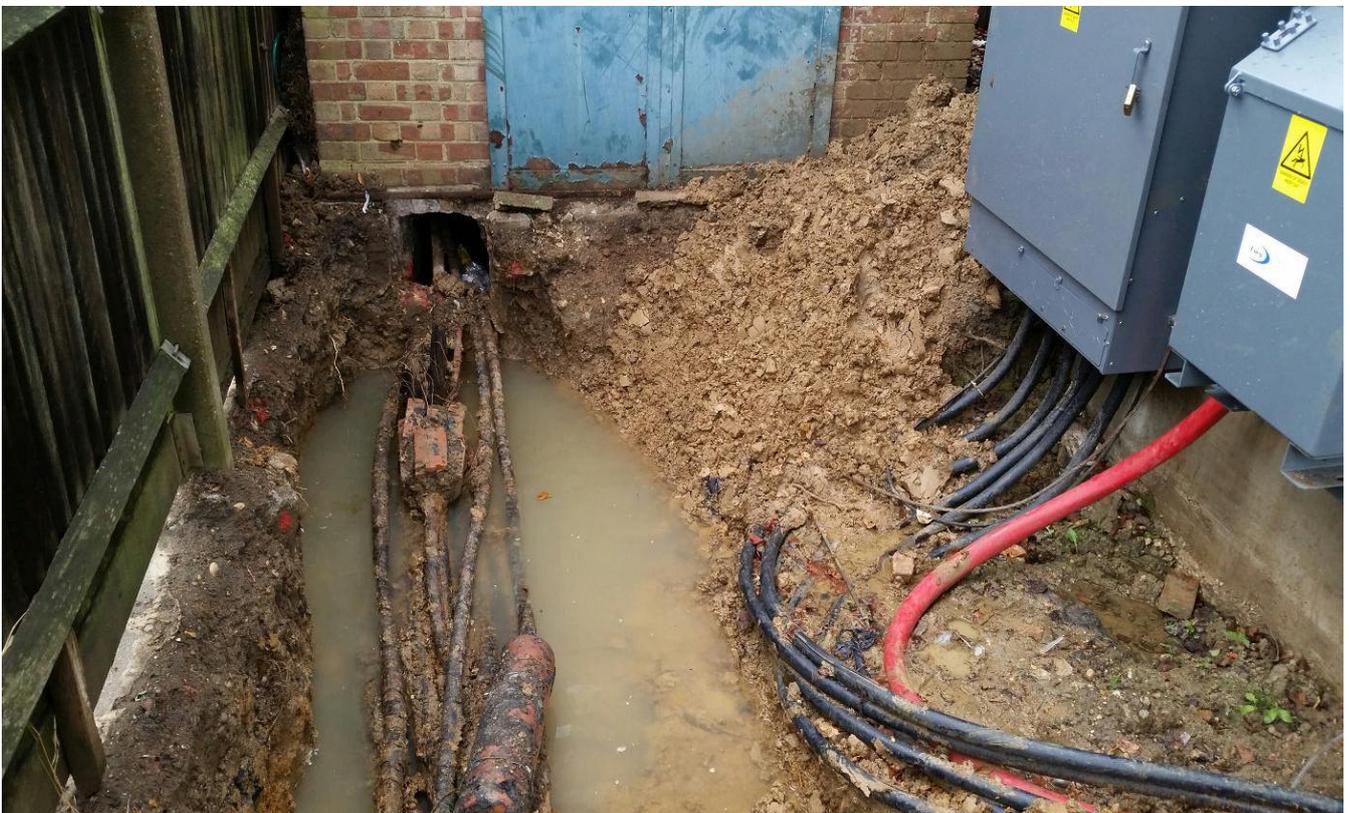
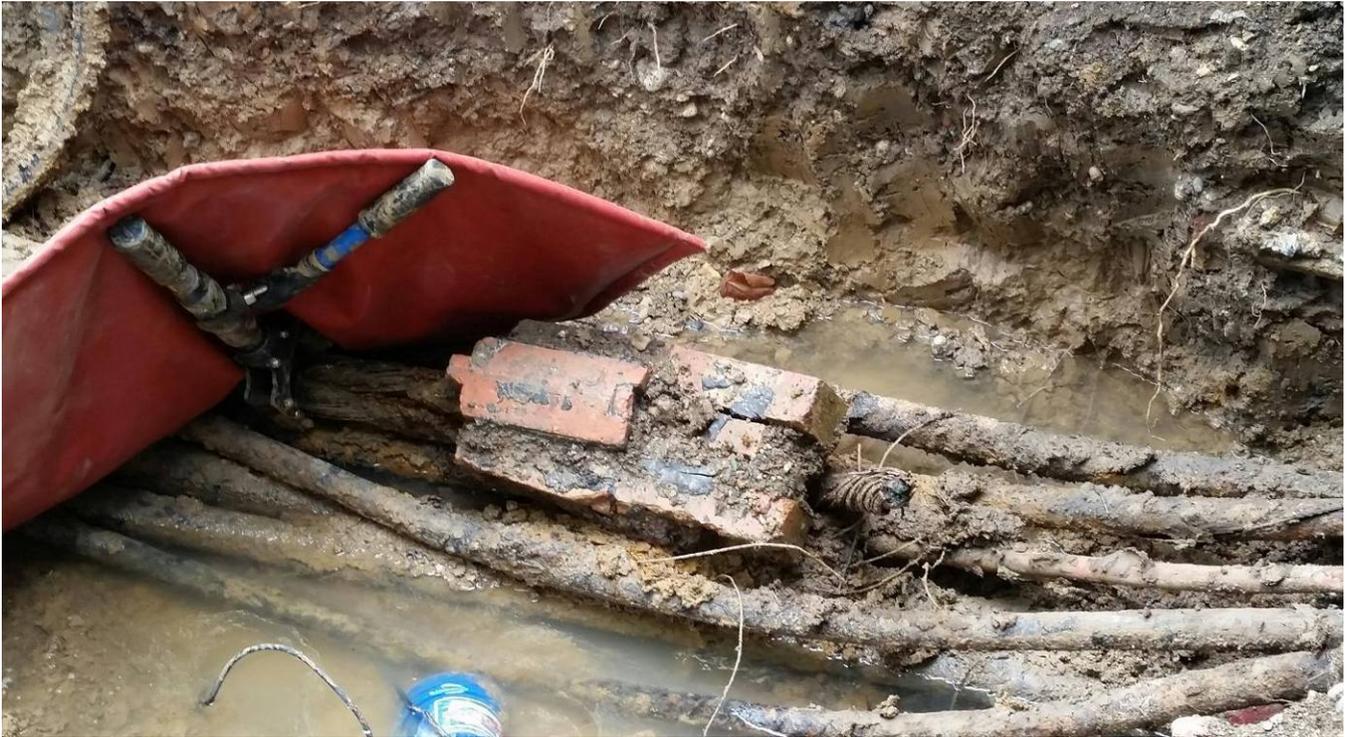
After removing three abandoned PILCSWA cables within the required work area, a brick construction, bitumen filled joint was found sitting on top of a number of cables including an abandoned cable. This joint appeared to have two undamaged PILCSWA cables entering from one end and a short length of cut PILCSWA cable exiting from the far end. (See photographs below). The joint and attached cables needed to be moved to access the planned work.

The engineer carefully examined the brick joint and raised the cut PILCSWA cable end, noting the two other cables lift with it, and decided that this was a breach joint. The plans could not identify a Live breach joint within the substation so the engineer decided that the joint and attached cables were abandoned and dead. A hand operated insulated hydraulic cable cutter was clamped around both of the PILCSWA cables that entered one side of the breach joint and proceeded to cut the cables. Approximately 80% of the way through the cutting process a flashover occurred. Both engineers were wearing all of the correct PPE and no injuries were sustained.

After safe isolation and investigation it was discovered that the joint was actually a Live pot end with an abandoned cut ended cable running underneath and attached to the underside of the joint.

1. Understand that a cut end is **NOT** proof that a cable is dead
2. Understand that all cables **MUST** be treated as **LIVE** until proven dead by approved means
3. Wear the correct PPE and use the correct tools..
4. Where there are redundant cables request the redundant cable records plans.
5. Ensure everyone has an input into on site risk assessment and information is shared.

1. Ensure all information is available before work starts including abandoned cable records.
2. Plan work in a timely methodical manor.
3. Carry out effective site engagements including checking Stage1 and Stage 2 IPP's.
4. Ensure everyone who works on LV cables complies with TG-PS-546
5. Ensure adequate space available to carry out the work safely.

1. Ensure training is carried out into the correct planning of Live LV jointing within a typical substation.
2. Ensure supervisors are carrying out effective planning and on site engagement.
3. Ensure everyone involved in identifying, working on, and setting to work on LV cables, is conversant with Low cable identification procedure - TG-PS-546.
