Transformer Tapchanger Braid Inspection

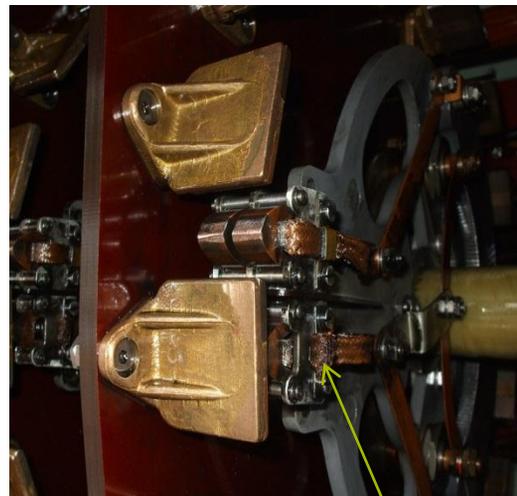
Following restoration of supplies after the isolation of an 11kV cable fault, the 11kV output voltages from a Primary 33/11kV 7.5MVA Transformer were found to be unequal and slightly reduced on two phases only. The problem was traced to a burnt-through braid coupling the main tapchanger (33kV) contact on one phase. Current was still flowing through the phase due to the fortuitous, and relatively high resistance, path of the contact mounting and retention components. The transformer was supplying a light load, and the 33kV load current had not caused further significant burning of these parts. Had the transformer been highly loaded it is probable that the defect would have rapidly developed and caused a disruptive failure.

Burnt through braid

Investigation showed that the braids had burnt through due to the cable fault current. This occurred only because many of the fine copper strands of the braid had previously mechanically broken, due to the repeated flexing over the many years they had been in service. Copper naturally work-hardens and becomes more brittle after repeated flexing. The few remaining strands had satisfactorily carried the low load current, but burnt through during the cable through-fault current.

- All staff involved with tapchanger maintenance should be aware of the mechanical deterioration of contact braids, and the need to carefully inspect them for broken strands.
- Contact braids found with broken strands must be replaced in line with the Maintenance Manual requirements.
- All replacement parts must be identical to those being replaced, or be replaced with alternatives that are specifically approved.

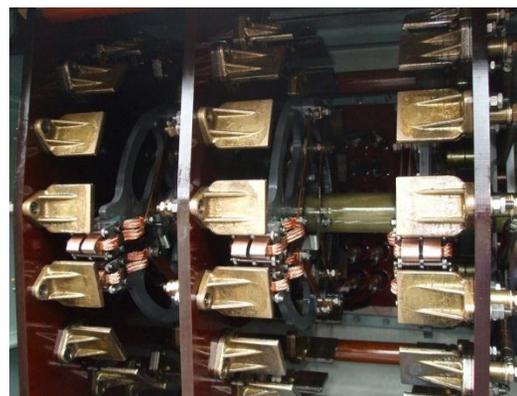
New braids fitted
