**Entry of a confined space on board
the cargo ship
SUNTIS
in Goole Docks, Humberside
on 26 May 2014
resulting in three fatalities**

MAIB SAFETY BULLETIN 3/2014

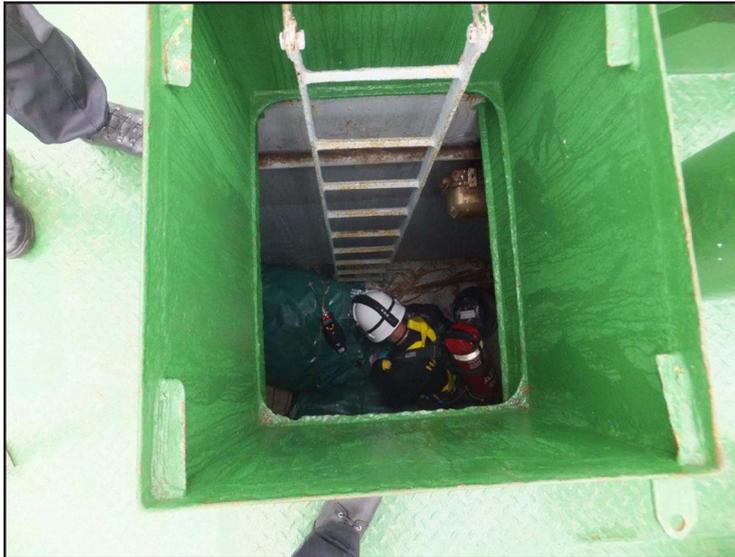
Figure 2

The Fire and Rescue Service analysis of the atmosphere after the accident showed normal readings (20.9%) of oxygen content at the access hatch; the readings reduced to 10% just below main deck level inside the hatch opening and to between 5% and 6% at the bottom of the ladder into the compartment (**Figure 2**). Such low levels of oxygen cannot support life. Anyone exposed to such levels will faint almost immediately, followed by convulsions, coma and respiratory seizure within a few minutes. It is likely that the timber cargo caused the deprivation of oxygen in the cargo hold and access compartments.
