## Disruptive Failure of Metal Clad Cut-out

During planned Rising and Lateral Mains modernisation works a 200amp Metal Clad cut-out disruptively failed badly burning an Electrician working in close proximity.

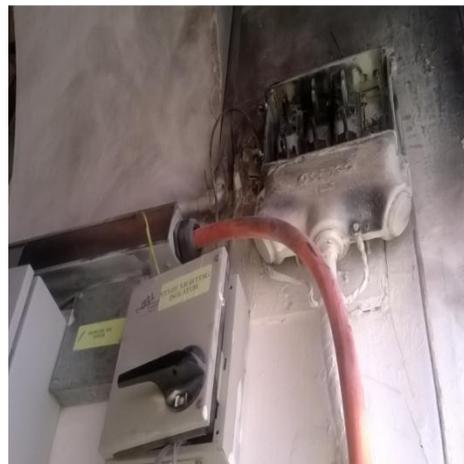
Isolation of the Rising Lateral Mains system had previously required the removal of the cut-out fuses. At this time minor degradation of a fuse carrier was noticed but this was not thought to be significant.

The activities around the cut-out (isolation and installation works) may have been contributory factors to the subsequent disruptive failure.

*Failed Cut-out situated a close entrance*

- Where there is evidence that a cut-out is in an unsatisfactory state action shall be taken to remedy the identified issue through repair or replacement before work commences.

- Consideration shall be given to the replacement of “end of life” cut-outs as part of planned modernisation works.

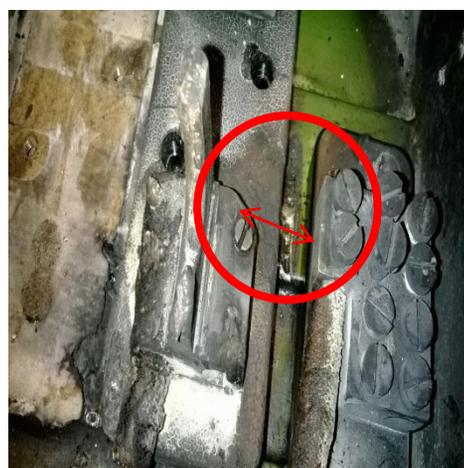
Following extensive examination of the recovered equipment, evidence of historic current tracking was noted between the L3 incoming phase terminal and the metal frame of the equipment.

*Arcing track between phase terminal and equipment frame*
