LIVE LV CABLE SPIKED IN ERROR

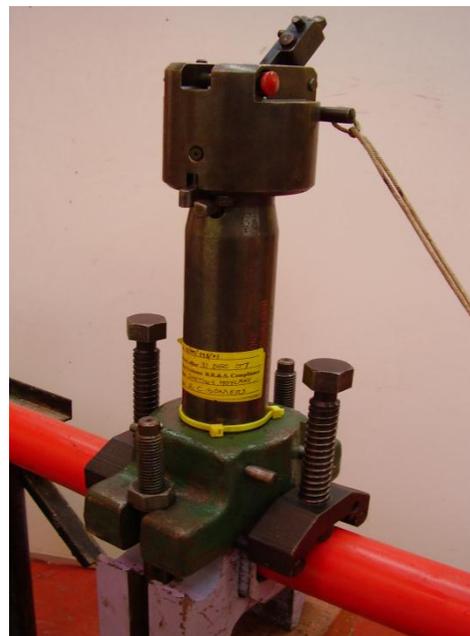
- The LV cable was a radial feed supplied via 3No 315A fuses. It was later discovered that these fuses had blown instantaneously when the cable had been spiked.

- The 6.6kV cable to be spiked was a non-standard 6-core cable. This was isolated and earthed and a sanction for test (SFT) issued.
- Prior to the spiking, all cables in the vicinity were exposed and the cable identified using an approved signal injection unit. This process also eliminated the other cables in the vicinity. The injected signal was strong and gave the SAP full confidence that he had identified the 6.6kV cable and there were no traces of the signal in any of the adjacent cables.

- Believing the identified cable to be the isolated 6.6kV cable, it was marked by the SAP who then removed the circuit earths and tested the cable prior to spiking.

- The first indication of something not being right was when no change of conditions were experienced during the post spike insulation resistance tests.

- The onsite SAP should immediately inform the Control Engineer who will liaise with the Incident Controller to monitor any no supply calls in the vicinity.
- The on site SAP shall consider the possibility that a live cable has been spiked and undertake a local LV network check.
- Any spiked LV cable shall be treated in the same manner as a damaged LV cable.
