Insulator Failure on a Morris Line ABSW at Mill Farm, Beeston.

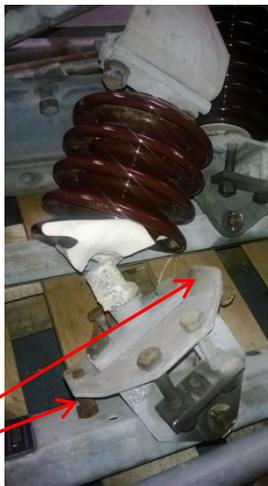
Aston Grange ABSW

An almost identical incident was reported to have occurred during a similar operation a few weeks earlier at Aston Grange ABSW, however, in both cases staff report that visual inspections and risk assessments prior to the works commencing showed no indication of, or the potential for, damage.

- Prior to the removal of the original handle mechanism, check the stroke length such that the correct hole is used in the replacement hook stick operating mechanism.
- Ensure the back-stops are fitted and set to prevent the rocking insulator from over-travel against the fixed contacts. If backstops are missing and cannot be fitted retrospectively then consideration must be given to replacing the ABSW.

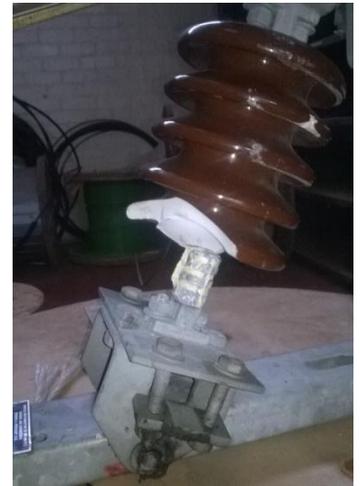
Mill Farm ABSW

During final opening and closing checks following the conversion of a handle operated Morris Line ABSW to "hook stick" operation, the lower end of the insulator on the rocking insulator on one of the three units failed causing porcelain shards to fall. Although none of the electrical sections of the switch failed, the switch was inoperable until a repair was undertaken to replace the faulty unit.

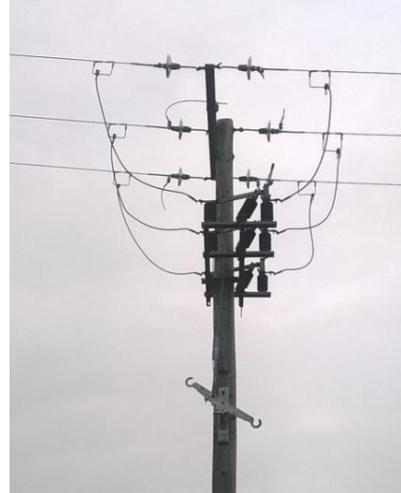
Mill Farm ABSW Following Retro-fit

Back-stops
