## SOP 383 – Long and Crawford GF3F et al

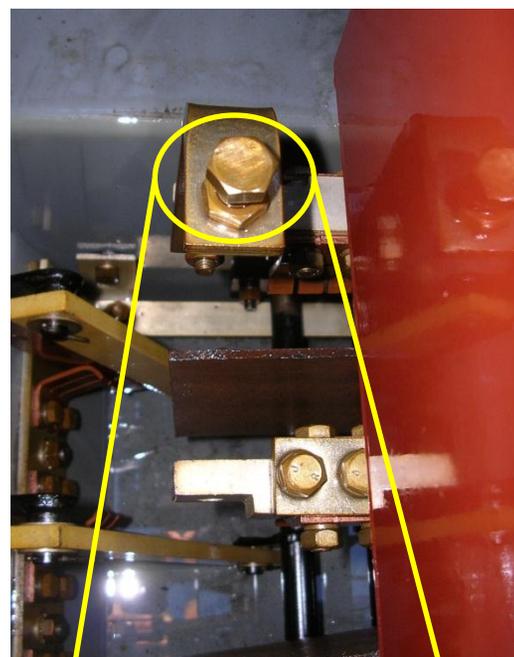
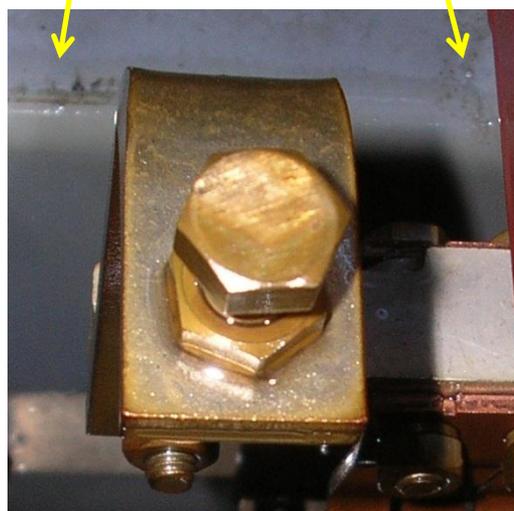
SOP 383 was initiated by Electricity North West in January 2013 and was implemented in our Company due to similarities with a switchgear fault in Uddingston in October 2012. The area of concern has been the fuseswitch busbar butt contacts – example shown in photo.

Some marks were noted but no signs of overheating have been found on any of the 63 contacts examined at 21 substations.

Intrusive maintenance on these plant types will be initiated in ED1 with an Additional Requirements Checksheet (SWG-13-174) to specifically inspect these contacts for signs of burning and damage. This activity will manage any risk arising from this issue going forward.
