BIDOYNG SAFETY CHECKS

Updated for clarification, Safety Bulletin B237 Issue 01 has been withdrawn.

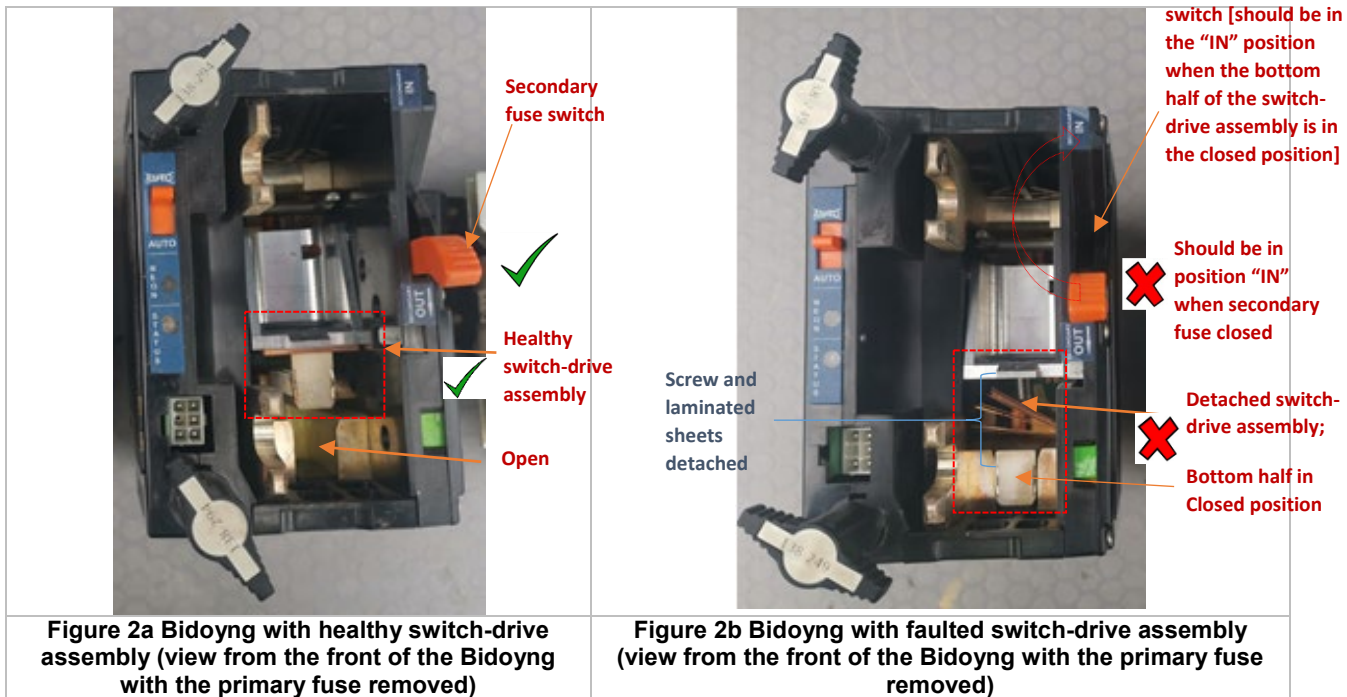
Following an examination of a Bidoyng from a site in SPN, during a fault job, a faulty switch-drive assembly was discovered (see Figure 2b). The damage was such that the upper half of the switch-drive assembly was detached from the bottom-half of the switch-drive assembly; the securing screws and laminated sheets had become loose (compare Figure 2a to Figure 2b).

The detached switch-drive assembly resulted in the secondary fuse switch erroneously indicating “OUT” (i.e. disconnected) even though the bottom half of the switch-drive assembly was in the closed position (the secondary fuse switch should have been in the “IN” position). The implication is that staff would have been unaware that both the primary and secondary fuses were both connected whilst the Bidoyng was still in service. Also, the feeder way would not have been adequately protected if both the primary and secondary fuses were connected.

- Prior to installing a Bidoyng, examine the unit to ensure that the switch-drive assembly is intact (as per the “Healthy switch-drive assembly” in figure 2a) and that it has no signs of rattling or loose connections.
