Technical Alert

ABB 50kVA Transformer MV Termination Eye Bolts

| Document Number: | DOC-140720-FVB |

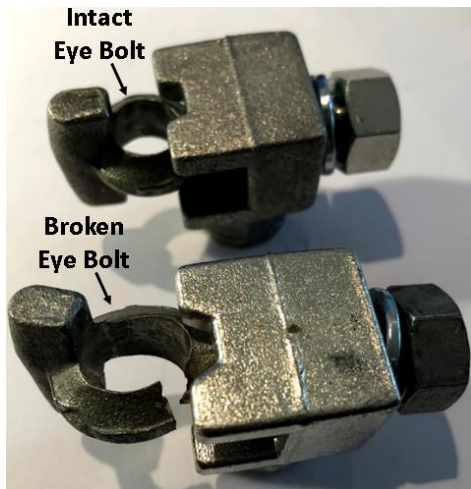
An issue has been identified which concerns the MV termination eyebolts used on the ABB 50kVA transformers. The MV eyebolt is fracturing with minimum tightening force applied, when terminating conductor in the eyebolt as per Figures 2 and 3 below.

Figure 2: Intact and Broken Eye Bolt

- All new ABB 50kVA transformers currently stored in ESB Ballycoolin have been quarantined until corrective measures have been put in place.
- All new ABB 50kVA transformers in local depots should not be installed until this issue has been addressed and corrective measures can be put in place.
- Depots that have ABB 50kVA transformers in stock should contact Ciarán McBrien Network Assets OHL, Ciaran.mcbrien@esb.ie 087 410 2720, to highlight how many units they have in the depot to allow for replacement parts to be despatched when available.

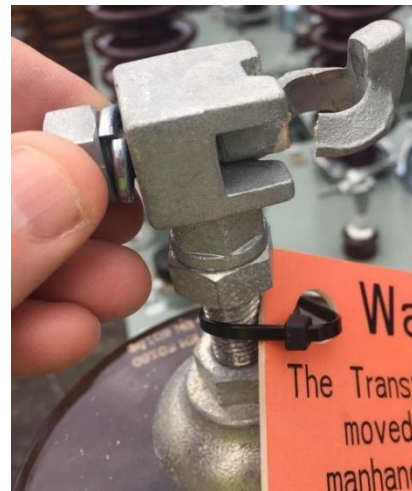
Figure 3: Broken Eyebolt on MV Bushing
