MEWP bucket detaches from vehicle in transit

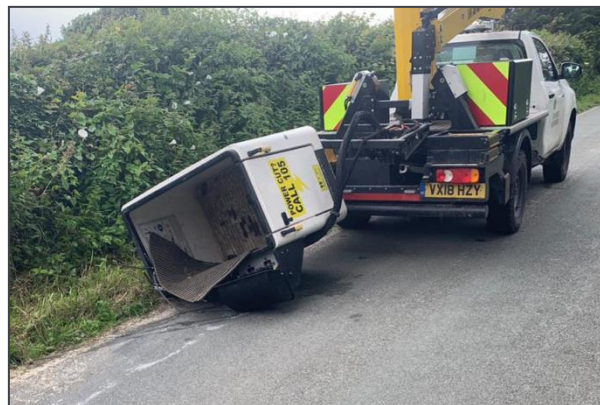
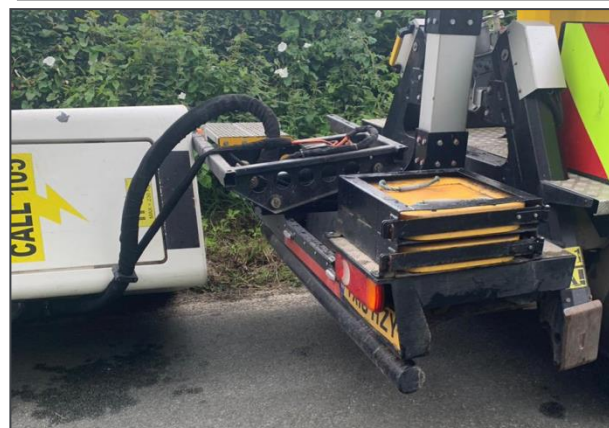
Initial investigations revealed that the bucket became detached when 3 of the fixing bolts became loose and the 4th bolt sheared off resulting in the bucket falling from its mounting platform. Two of the fixing bolts were found resting in the chassis of the MEWP with no sign of a stress fracture or fatigue found on them.

Typical bucket platform mounting with threaded bolt fixings in each corner

- Fleet business in conjunction with the supplier are undertaking safety checks of all Toyota Hilux MEWPs in SPEN of which there are 44 vehicles (24 in SPM and 20 in SPD) – First 8 vehicles have not found any similar issues or defects with the bucket fixing bolt assembly.
- All SPEN staff who use or drive a SPEN vehicle and in particular a Toyota Hilux MEWP are reminded of the need to complete a full inspection of their vehicle using the VC40 document before starting their journey.
- In regard to drivers/operators of a Toyota Hilux MEWP, staff should check that the bucket is secure and there is no movement on its platform mounting and also check the 4 fixing bolts before their journey or use.

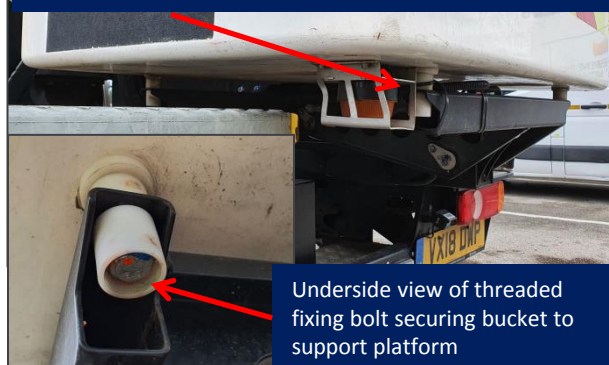
Underside view of threaded fixing bolt securing bucket to support platform
