4th August 2020 INTERNAL

## Contractor seriously injured in fall from the rear of a flatbed lorry

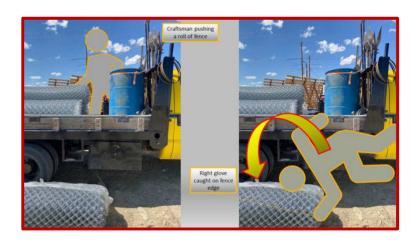
On Monday 27 July 2020, a BHE sub-contractor was seriously injured whilst unloading 108kg rolls of steel chain link fencing from a flatbed lorry. The accident is currently under investigation, but initial findings indicate that one of the craftsman's gloves became caught in the sharp edges of the fence.

The craftsman was pulled from the truck to the ground approximately 1m below injuring his head, shoulder and elbow.

- Edge protection on our vehicles is there to prevent accidental falls from height.
- Use mechanical means to load and unload where available.
- If it is necessary to lower the edge protection for any reason, off load from the ground where possible.
- If the edge protection has to be lowered whilst personnel are working on our vehicles, a documented risk assessment with adequate additional control measures is required and must be in place prior to carrying out the work.

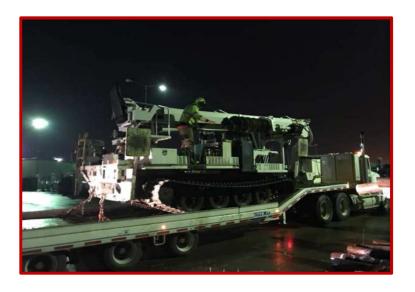
In a second incident, a BHE employee had returned to a depot with a GoTrack (tracked vehicle) loaded on a low trailer. Our injured colleague was on the deck of the GoTrack throwing items to the ground, approximately 2.4m below, when he fell resulting in a fracture to his right lower leg.

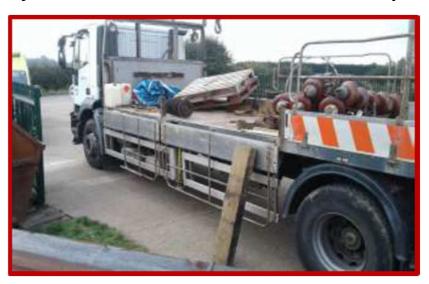
These incidents are similar to one which occurred in Northern Powergrid in 2018 when a Linesman suffered a fractured leg after falling from a vehicle. The linesman was throwing a set of insulator into a skip, which was approximately 1.5m away from the lorry. The arcing horn on the base of the insulator set caught his overalls and this momentum caused him to fall from the vehicle.
