Issue Date:	10/4/15	SIGNIFICANT INCIDENT ADVICE (SIA) Be Safe Pro18.2F

SIA No:	SP0284-5-183	Issuing Company:	Ausgrid		
Status of Advice:	<input checked="" type="checkbox"/> Preliminary <input type="checkbox"/> Final	Incident Date:	1/4/15	Incident Time:

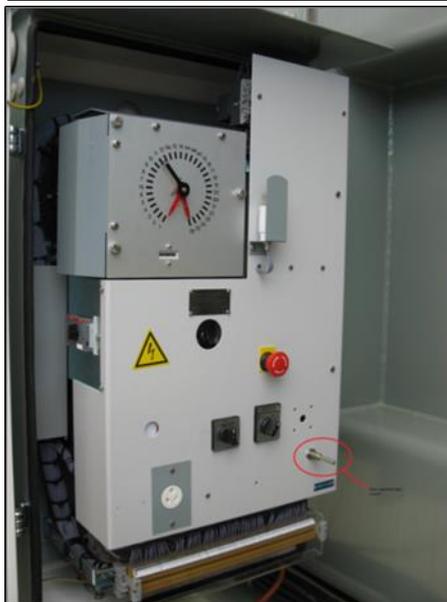
Description
 A Substation Technician was carrying out a routine inspection of Mt. Thorley Zone Substation when he touched a light switch on a metal cabinet and reported (to his supervisor) feeling a minor electric shock (see circled area on photo to the left).

Extent of Impact
 Electric shock sustained with no reported ongoing health impacts.
 The maximum voltage received by the technician was potentially 220v, but it is believed he received substantially less than that due to the fact he was wearing rubber soled safety boots.

The area was quarantined and the light switch tested and found to be live at 220v.

The switch was disconnected and the control box was made safe. The Technician went for a precautionary ECG.

There are approximately 250 of these units on the network. Each switch will be checked for this defect with results of ALL tests recorded and reported. Details of the date tested, substation name and transformer number are to be included in the report.

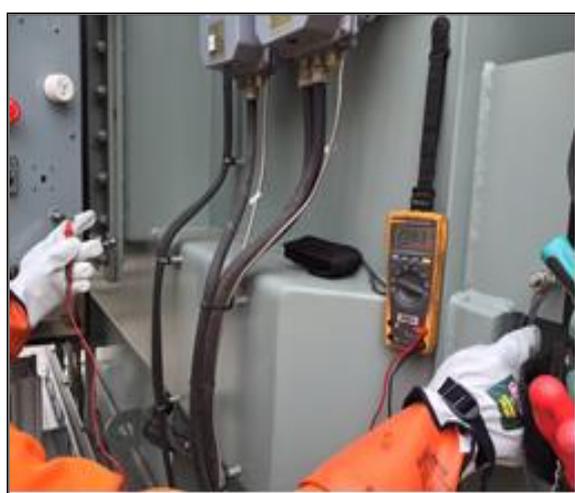
Additional Comments
 Light switches on all tap change control boxes of this type are to be treated as alive until the voltage between the switch and a known earth is measured using a multi-meter.
