# SIGNIFICANT ELECTRICAL SAFETY INCIDENT ADVICE

esaa **02/2004**

DATE: 06/04/2004	NUMBER OF PAGES: 2 (INCLUDING THIS SHEET)
DATE OF ACCIDENT/INCIDENT: 22/11/03 DATE OF INITIAL TRANSMISSION: 06/04/04	esaa NUMBER: 02/2004 esaa DATE OF TRANSMISSION: 06/04/04

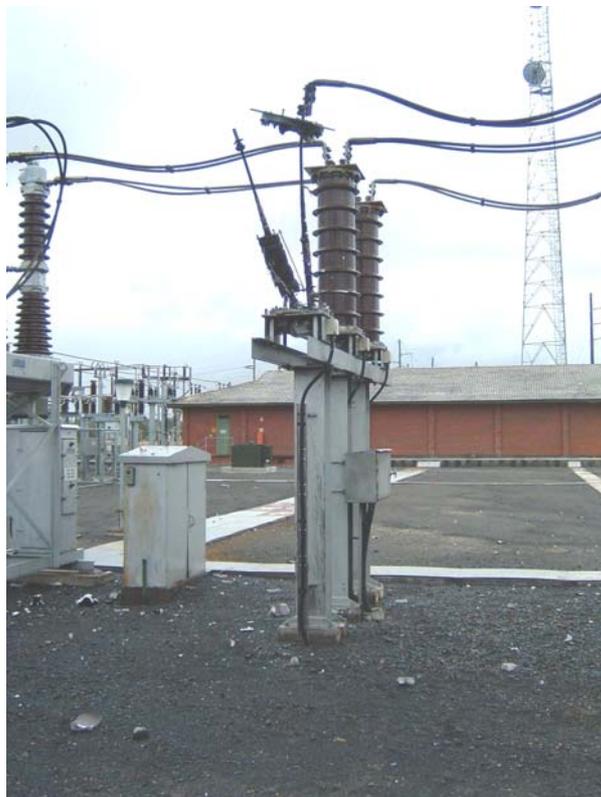
During normal service a 66kV Current transformer, Tyree type 06/66/16 failed explosively, scattering porcelain throughout the switchyard. The fault was interrupted successfully by the bus bar protection. It was the first time that a unit of this type had failed explosively.

There were no injuries to staff or public. Damage was sustained to the adjacent CT and circuit breaker.

The cause of failure is inconclusive, and further investigations are underway to help determine whether other CTs with poor tests results indicate if the failure could be associated with a faulty DLA tap connection to earth.

These units have a glass oil sight bulb at the base. This was broken on the failed unit, which may have been the result of internal pressures, or if vandalised or otherwise, loss of oil could have been the cause of failure as there was arcing damage to the upper portions of the hairpin primary conductor.

In the meantime, it is recommended that the integrity of DLA connections be checked where there is a possibility of corrosion due to dissimilar metals.
