DATE: 08/06/2005	esaa NUMBER: 05/2005
DATE OF INCIDENT: 5/05/2005	ALINTA NUMBER: 2005 – 003

Brief description of accident/incident (include voltage):

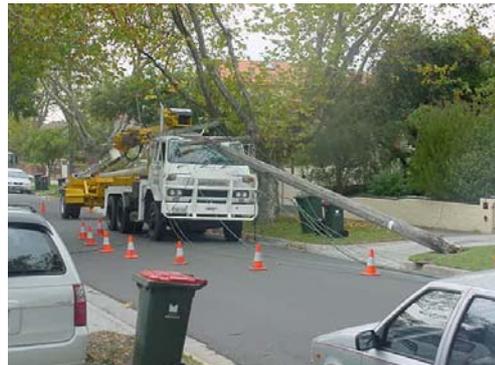
Whilst undertaking planned construction work, an Alinta work crew were lowering the High and Low Voltage (HV/LV) conductors from a strain pole, which then altered the load characteristics on the adjacent pole. After a short period of time (approx 2 - 5min) this increased sideways load resulted in the pole breaking and falling on to a contractors Pole Erection Recovery Unit vehicle (PERU).

No injuries
HV/LV intermediate pole snapped off at base.
Contractor PERU sustained damage to the cabin of the truck.

- Risks and Hazards shall be assessed and documented prior to the lowering of conductors.
- Temporary supporting of poles to be considered prior to the lowering of conductors. Taking into consideration: -
 - Age of the pole
 - Condition of the base of the pole
 - Increased force on adjacent poles
 - The support of the conductors
