SIGNIFICANT INCIDENT ALERT

Safety Gram number **esaa 01/2005**

Safety Gram topic: LVabc Hooked Bracket & Suspension Clamp Failure
Applies to: CitiPower Pty Powercor Australia Ltd

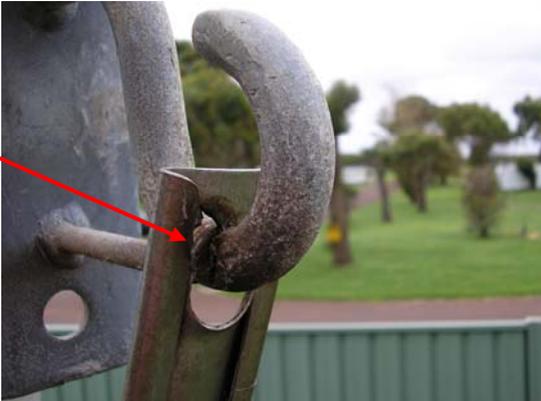
Suspension clamp damage.

Wind vibration on the LVABC resulted in the suspension clamp rubbing against the Hooked Bracket. Over time this action has fatigued the metal of the suspension clamp and resulted eye hole in the suspension clamp being enlarged (in one case to the point of failure), and the hooked bracket being cut into.

Brackets and suspension clamps replaced and reported to Asset Failure Representative.

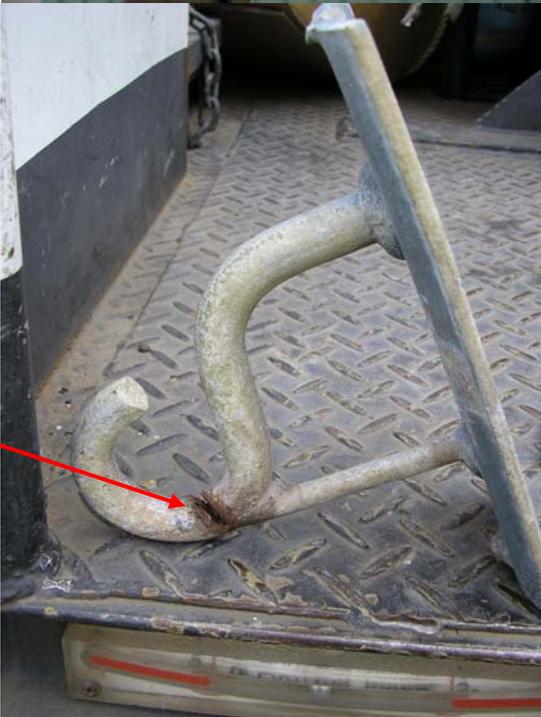
Abrasive action of the suspension clamp has cut in to the hooked bracket.

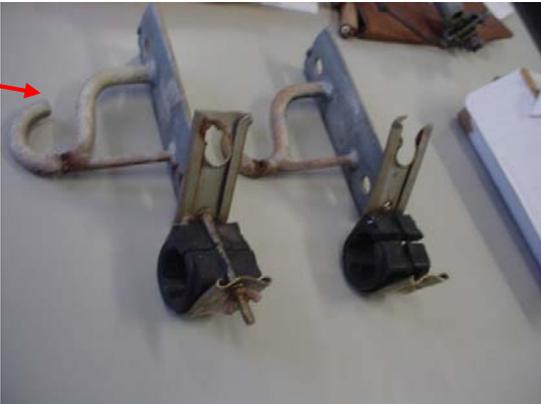
2 recent cases of 95mm LVABC suspension clamps and hooked brackets and having shown signs of excessive wear & fatigue being identified in the past 6 months. Both incidents were in the Warrnambool area, and are of the early LVABC construction standards. In one case the suspension bracket has worn completely through, and allowed the 95mm LVABC to fall unsupported

Damaged and failed suspension clamps and hooked brackets.
