SIGNIFICANT INCIDENT ADVICE

ESAA No: 21/2003

DATE OF INCIDENT: 12/03/2003
AURORA REFERENCE NO: IRIS 1851

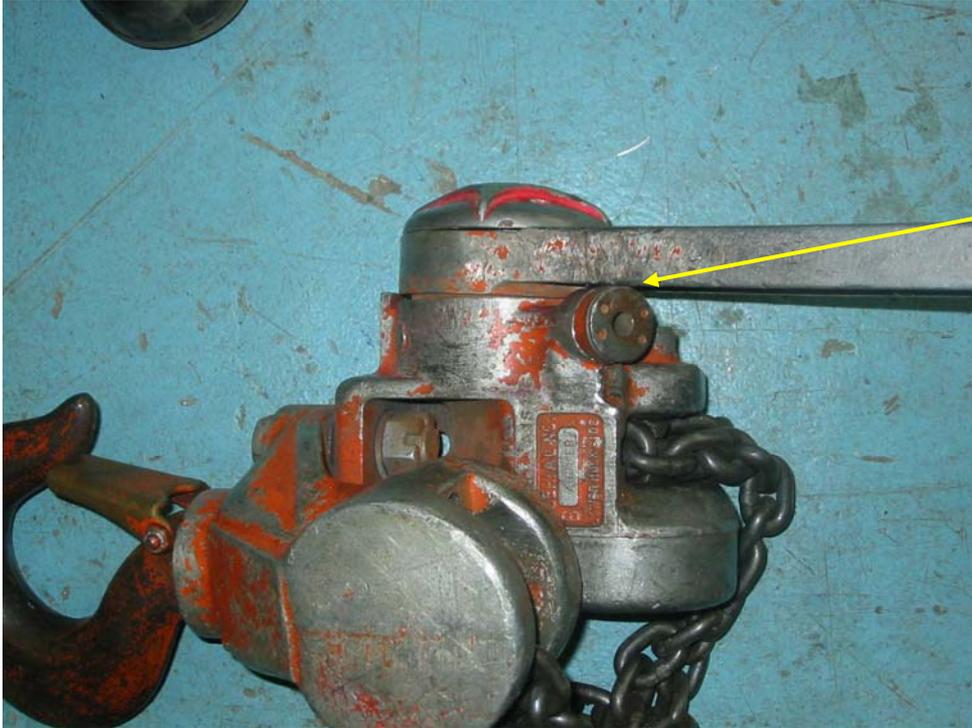
The chain lift was removed from further use and tested. Under load the failure could not be reproduced, it was then stripped down. No components showed wear to indicate why the unit had failed. Further examination found that the lever arm of the chain lift had a slight bend towards the body of the unit. There was also some slogging wear that allowed the arm to move and contact the ratchet plunger. (See photo) It is now believed that while in use the lever arm was being pulled across the body of the unit and contacted the plunger at a critical instant holding the plunger out, allowing the chain to free run.

Photograph showing the contact point

**Contact between
the lever arm and
the ratchet plunger**

All chain lifts of this type have been retested. This involved stripping the units down for a visual inspection as well as the standard load test. They were also checked for contact between the lever arm and ratchet plunger. One other unit was identified where the lever arm was found to be in contact when a sideways pull was applied.

Although this was an unusual occurrence future inspections will include a check for contact between the lever arm and the ratchet plunger.
