# HSE Alert Form

Alert Number: **2014.41**

<b>eSafe No</b>	1117363	<b>Location</b>	Side St, Gladstone	<b>Date</b>	24/08/14
-----------------	---------	-----------------	--------------------	-------------	----------

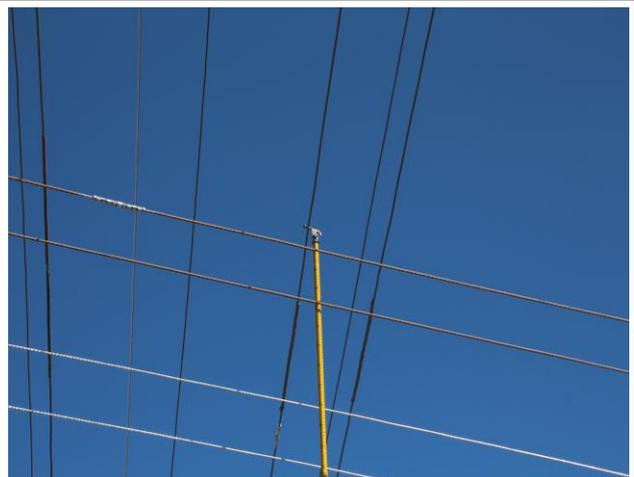
An LV mid span circuit crossover was in existence 3 ½ spans away from the isolation area, changes in conductor tension during the work have resulted in conductor clash, and subsequent conductor failure.

The work crew have not observed the reduced clearance and the circuit fly over during their risk assessment process. Subsequently no control measures were put in place.

The field crew have altered conductor tension at the work area, allowing sufficient conductor movement for contact between LV circuits to occur at the flyover.

Line Managers and Supervisors to reinforce the requirement to control reduced flyover/crossover clearances with tiger tails or similar controls to prevent the risk of conductor clashing when identified.
