# HSE Alert Form

Alert Number: **2014.10A - this alert supercedes Alert 2014.10. Please refer to the mark in the right margin for changes to the previous version**

<b>eSafe No</b>	INC-1115311	<b>Location</b>	Bundaberg	<b>Date</b>	16/03/2014
-----------------	-------------	-----------------	-----------	-------------	------------

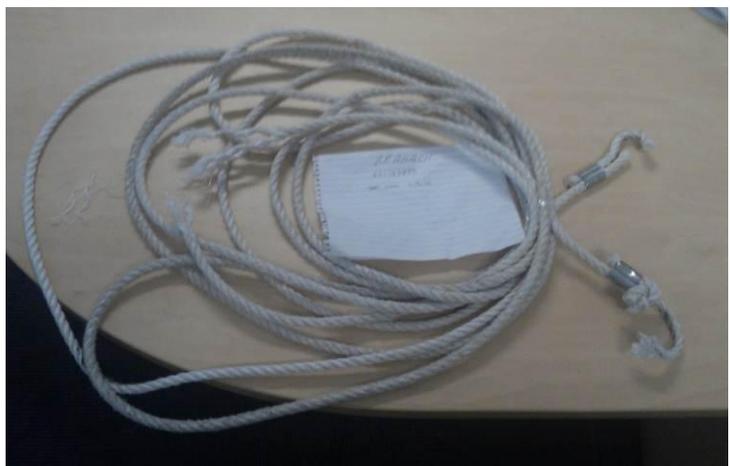
While setting up an extension ladder on a pole, the ladder operating rope broke causing an employee to over balance.

When the ladder operating rope broke, the employee fell backwards to the ground resulting in a back and neck injury.

The rope that broke was a twisted 3 strand poly rope as illustrated in this photo.

Ergon Energy specifies 11mm Kernmantle rope, not poly rope.

Supervisors and Line Managers are to arrange for immediate inspection of all ladder ropes. In particular, the inspection that the rope is Kernmantle of the correct size, runs freely through pulleys, has no cuts/frayed fibres with the end of ropes securely fitted.

Inspect ladders to ensure operating ropes are Kernmantle. Ladders not fitted with Kernmantle operating ropes are to be quarantined until repaired.
