ELECTRICITY
SUPPLY
ASSOCIATION
OF AUSTRALIA
LIMITED

ESAA 09/2003

DATE:	20/01/03	NUMBER OF PAGES:	1
DATE OF INCIDENT:	19/01/03	UE NUMBER:	2003 - 001

Brief description of accident/incident (include voltage):

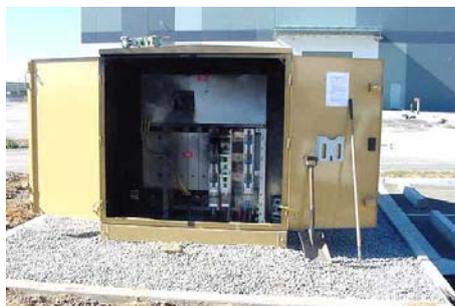
Whilst undertaking a Low Voltage(LV) Phase Sequence (Rotation) test as part of commissioning a 1000kva kiosk substation upgrade, a flashover occurred at the LV board. Two electrical fitters received serious burns to their face, neck and arms and were taken to hospital where they are in a stable condition.

- The work crew called an ambulance, administered first aid and advised the United Energy control and dispatch centre.
- The site was made safe.
- United Energy and the Office of the Chief Electrical Inspector (OCEI) attended the site and commenced an investigation into the incident.
- After the onsite investigation, required repairs were completed and supply restored.
