SIGNIFICANT ELECTRICAL SAFETY INCIDENT ADVICE

Western Power

ESAA 10/2003

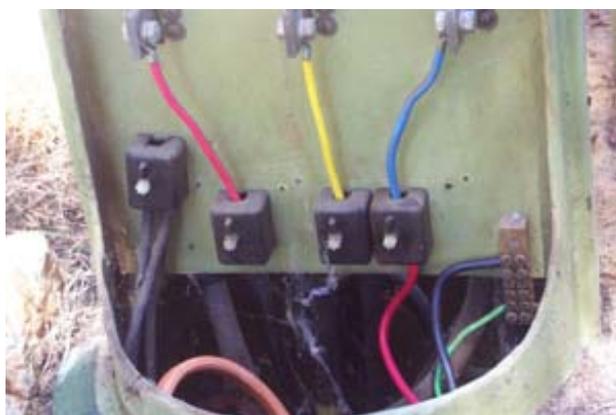
Crewmembers installing an underground service cable neutral found the 16mm cable did not fit the existing neutral link. Performing the appropriate test they identified what they believed to be a second neutral link situated next to the Red phase terminal then proceeded to connect the upgraded service cable neutral to this terminal.

The customer's neutral cable was inadvertently connected to the streetlight terminal. The streetlight conductors were black double insulated and were de-energised during daytime hours.

Two days after the service installation the customer reported a fluctuating power supply and damage to appliances.

- Where there is uncertainty about a service connection – stop and ask.
- Neutral link connections must match the conductor size.
- Label the streetlight circuit links.
- Training in service connection testing to include hazard details.
