SAFETYGRAM

Date Issued esaa – 3/10/2005
esaa Number – 09/2005

Galvanising Slag in Light Poles – Re-occurrence

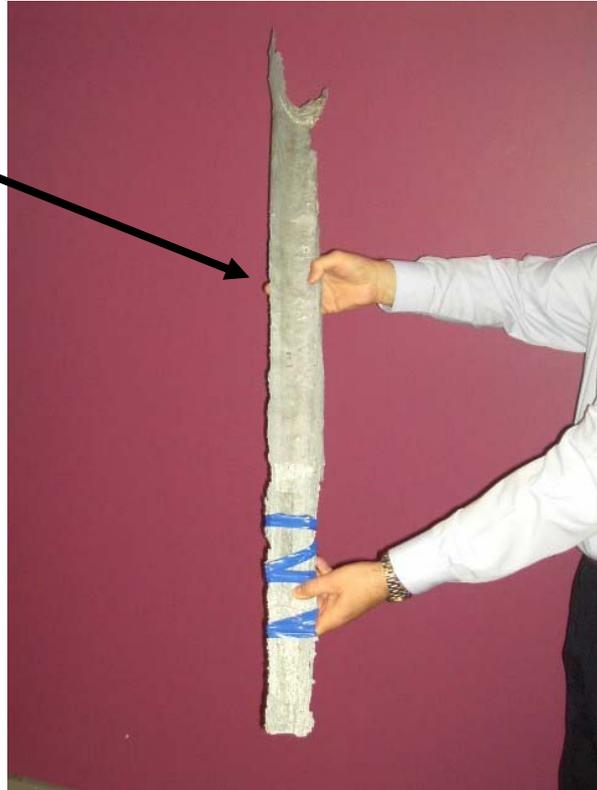
Whilst standing a nine metre steel light pole, a large piece (4-5kg) of solidified galvanising slid down the inside of the steel light pole casing. Two similar incidents occurred in July and October 2004.

The light poles are supplied complete from Vicpole and on three occasions solidified galvanising has dislodged from the pole internals whilst being installed.

Galvanised 'Slag' that slid out from inside pole

- **Effective immediately, no work is to be carried out on any Vicpole galvanised (including powder coated exterior) street light pole by t squared employees or contractors. This includes erection, commissioning, fault rectification and testing.**
The only exception is fault rectification where all work is limited to the exterior of the column, i.e. replacement of photoelectric cells or streetlight heads.
These poles can be identified by the manufacturer's name stamped on the outside of the light column (see photo over).

- **Until the issue is resolved, installation of Vicpole galvanised (including powder coated exterior) streetlight poles in the SP AusNet distribution area is to cease immediately.**

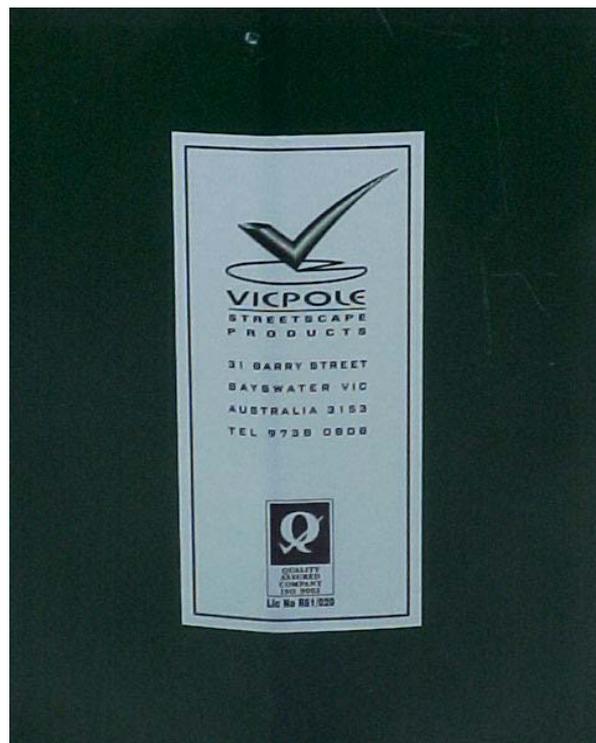
Manufacturer's Nameplate identifying poles covered by this alert:
