SAFETY GRAM

Safety Gram number Citipower/Powercor

30-05

Time: 1203
Date: 17th August 2005
Location: New Gisborne

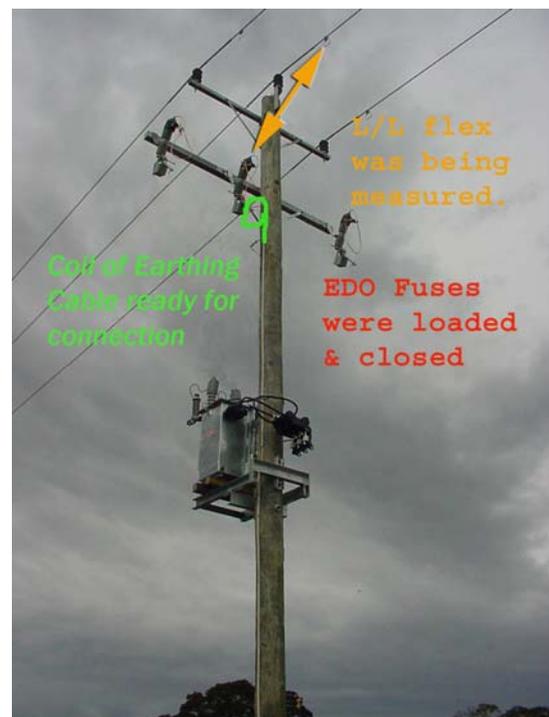
Whilst undertaking HV Live Line Work during the construction of a new pole type S/S, deliberate momentary contact was made between the live centre phase O/H conductor and the LL flex that was attached to the centre phase HV fuse unit during the process of establishing the length of flex required. The HV transformer leads were not attached at this stage of the construction.

Whilst the momentary contact was made an earth wire (to be used for a HV earth that was coiled on the pole) made contact with the fire choke on the bottom of the fuse unit. It is believed that this cable was clear from the units and was moved with a gust of wind.

When the earth cable contacted the fuse unit the EDO fuse operated with feeder protection also operating causing the feeder CB to trip.

It was not identified that the loose earth coil proposed a potential risk.
If the EDO fuses had been removed the potential for the incident would not have occurred.

The earth cable that was energised was coiled and lying on the ground at the time of the fuse operation. This could have resulted in a more serious incident if someone was standing in close proximity to the coil of earth cable at ground level.

Crews should be aware of potential hazards that may become apparent throughout the duration of the job.

Any energising of assets should be undertaken in such a way as to minimise the amount of equipment that is to be made alive. eg "only energising to the top of the fuse units"

The incident reinforces why no other work shall be undertaken on a structure while Live Line activities are being undertaken.
