ElectraNet SA
Asset Maintenance
55 East Terrace
Adelaide SA 5000
Phone: (08) 84047108
Facsimile: (80) 84047447

ESAA No: 13/2003

Subject: Current Transformer Failure

Accident/incident details: -	
DATE OF INCIDENT: 25-1-2003	NUMBER OF PAGES: 2
	Location: Robertstown Substation, South Australia

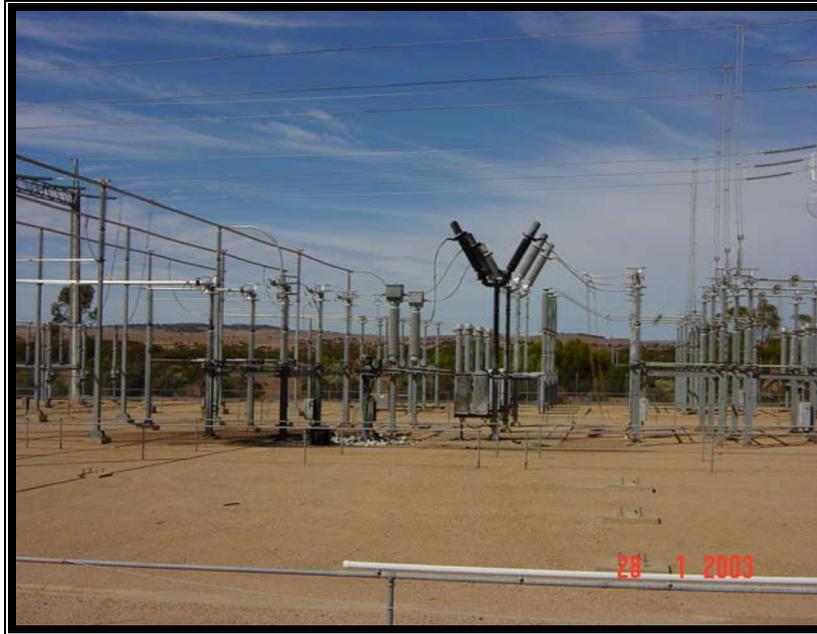
Brief description of accident/incident: -
At 1845 the internal insulation of a post mounted 275 kV current transformer (CT) failed. As a result the CT catastrophically failed and the oiled contained within the CT caught fire. The local Country Fire Service (CFS) was called and after ensuring the area was safe, the CFS entered the site and extinguished the fire.

Photo 1 – Current Transformer location.

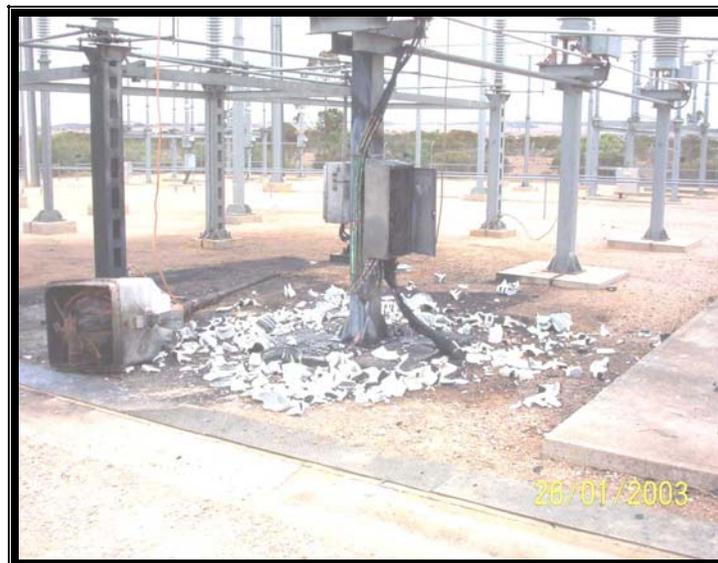
The fire damage was restricted to a 3-metre radius (refer photo's 2). The terminal lid and the CT lid were located 45 metres & 15 metres away respectively, inside the substation.

Photo 2 - Damage predominantly restricted to a 3-metre radius.

Extent of injury/damage: -
Nil injury to personnel.
Replacement of the CT was required.
