## **SAFETY GRAM**

### **Safety Gram number 14-06**

**Time:** Not known  
**Date:** Discovered 17<sup>th</sup> October 2006  
**Location:** North Melton

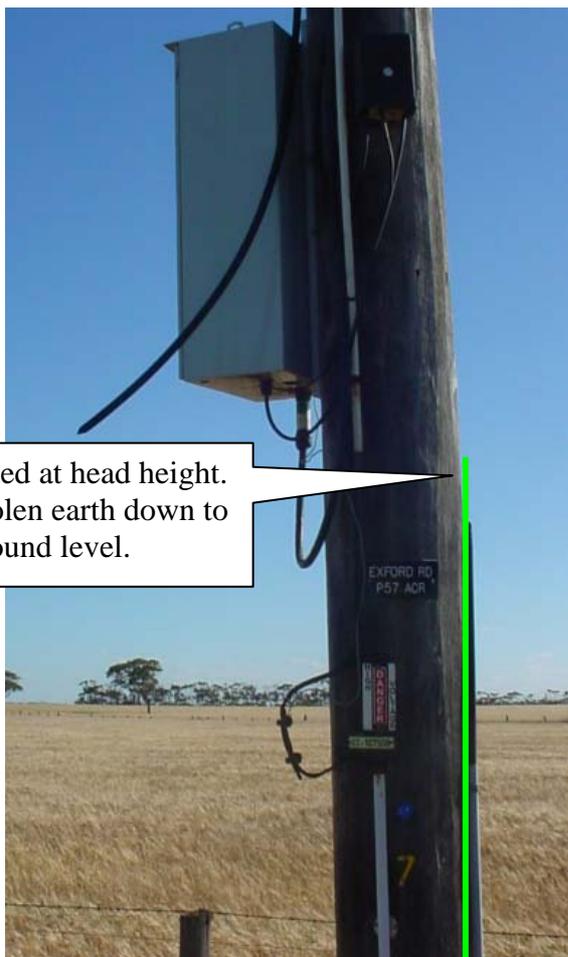
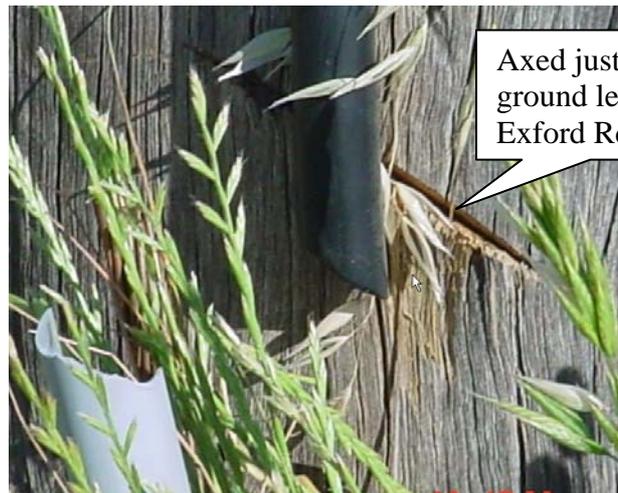
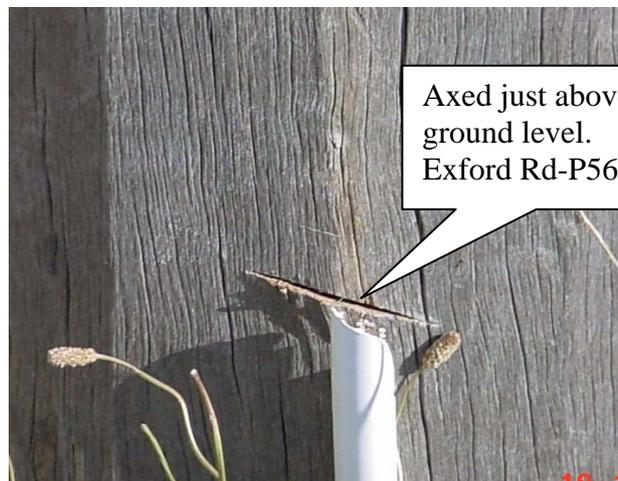
**Technical Officers found a section of earth had been removed from an ACR located at Melton North. Further investigation has uncovered earth cable also removed at another two substations in this area.**

Persons unknown have been using an axe or tomahawk to cut through the earth. Earth has then been removed.

If equipment which has had the earth removed becomes faulty the frame could become live presenting a Hazard which could cause death by electrocution.

Police have been notified of these thefts.  
All the earths which have been discovered stolen or damaged have been repaired.

Persons working on equipment are advised to check integrity of earths prior to approaching any pole with permanently installed earths such as Substation's, ACR's, Remote Controlled Gas Sw's etc. If found report any cut or stolen earths to the Control Room or local Asset Performance Officer.
