Electricity Supply  
Association of  
Australia Limited

**ESAA No: 24/2003**

<b>DATE:</b>	23/06/03	<b>NUMBER OF PAGES:</b>	1
<b>DATE OF INCIDENT:</b>	Various	<b>UE NUMBER:</b>	2003 - 004

There have been several Glove and Barrier incidents on the United Energy network:-

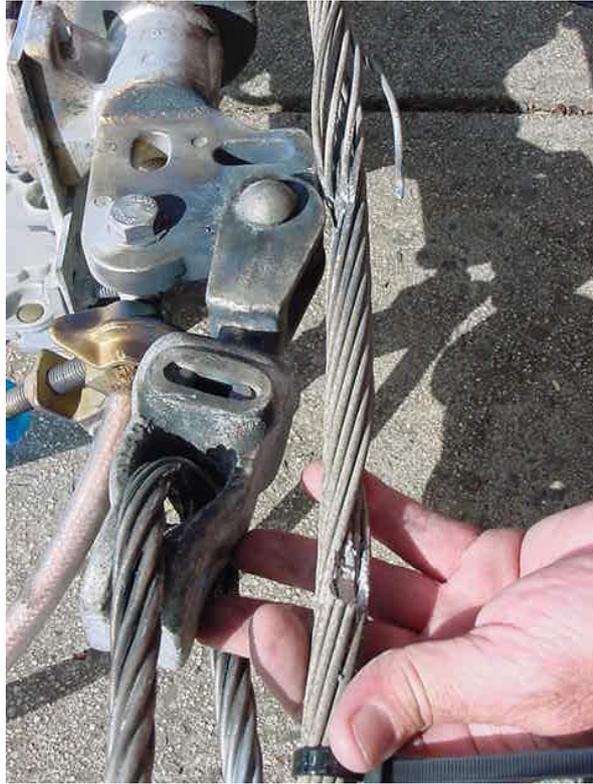
1. A G&B contract crew was installing a set of midspan isolators when a flashover occurred as a result of an isolator making contact between two phases. Ineffective equipment handling and insufficient cover were the primary contributing factors

Midspan isolator damaged in incident 1

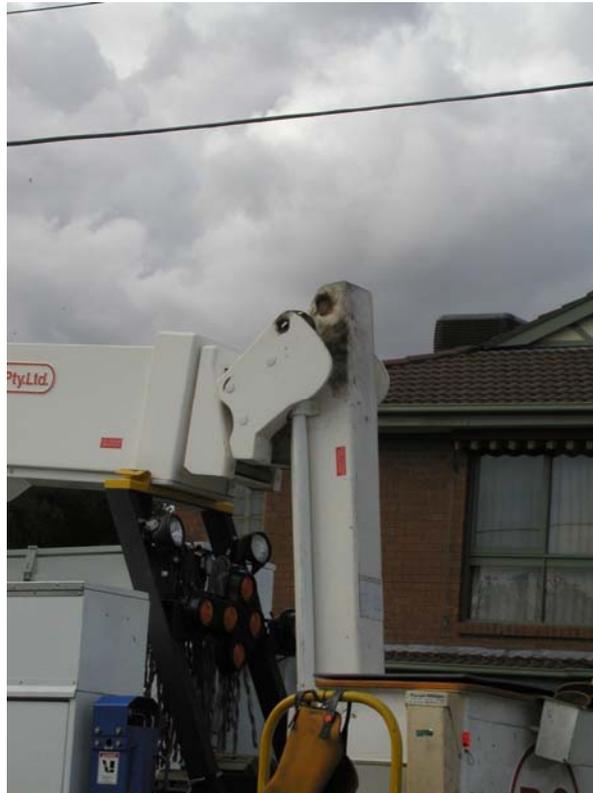
2. A contract crew was involved in installing animal protection utilising Glove and Barrier techniques. After completing the work the crew were in the process of moving the EWP basket from the working position when they inadvertently contacted the uninsulated portion of the EWP boom with the roadside conductor causing feeder system protection to operate.

Fly boom from incident 2

- United Energy and the contractors investigated all incidents.
- In the second incident, the boom of the EWP was removed from service, inspected by an independent third party and no sign of damage found.
