EnergyAustralia

ESAA No: 34/2003

DATE: 6/08/03	Number of pages: 1 (including this sheet)
DATE OF INCIDENT: 14/04/03	REPORTED BY: EnergyAustralia

Details of Incident:

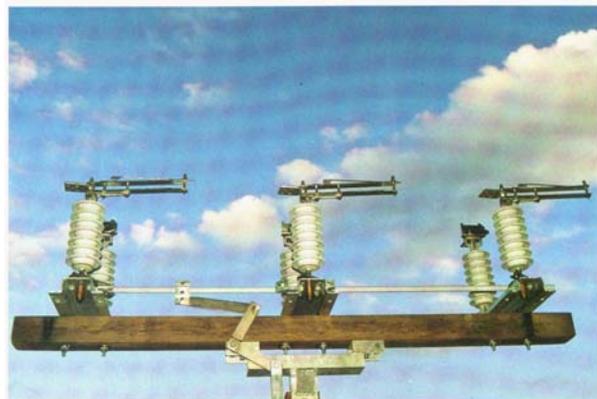
A support insulator failed on a Haycolec 12kV Air Break Switch while the switch was being operated. This placed operating personnel at risk due to falling porcelain.

Investigation has revealed that the failure was related to corrosion of the internal pin/plate assembly cemented into the insulator.

Initial inspections indicate that several other switches of this make show evidence of the same potential failure mode.

Haycolec Air Break switches can be identified by their single cross-arm mounting arrangement, as shown on the adjacent photograph.

Until otherwise directed, operators have been instructed not to operate Haycolec 12kV Air Break Switches without an inspection of the insulators for cracks in the porcelain.

New Haycolec units will be supplied with insulators without internal insulator pin/plate assemblies (noting that "Haycolec" is now trading as "AK Power Solutions").
