Safety Advice 02-2013 June (Aust)

Incident Alert Form

Franna Crane Incident – Snowtown, South Aust.

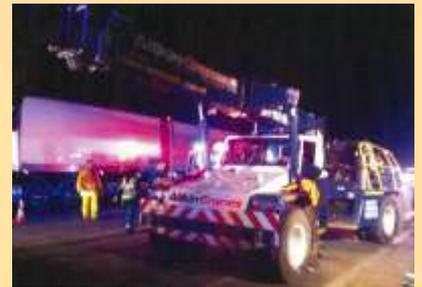
A 20 tonne articulated, rubber tyre crane was travelling on a main highway at a speed of approx. 65kph. After crossing railway lines the vehicle became unstable. The instability was amplified as the driver tried to correct and the crane tipped. The crane dug into the tarmac and barrel rolled in the air before landing on its wheels. The driver was seriously injured with severe lacerations to the head and a fractured collar bone.

This incident occurred in South Australia where the speed limit for this vehicle type is 85kph. In New South Wales the Speed Limit for this vehicle type is 45kph.

This type of articulated crane is known to have had previous cases of similar incidents (loss of control due to articulated and hydraulic steering nature of vehicle). A safety alert was issued in 2009 for a previous incident.

1. The contractor has issued Safety Alert to ensure that all articulated crane units of this type adhere to a maximum speed of 40kph.
2. If transport for longer distances is required (i.e. speeds above 40kph) then a flat-bed truck will be used.

1. The legislated speed limits for this vehicle type are not a suitable guideline for safe operation.
2. Hazard notification and learnings from safety alerts have a lifespan and a process for ongoing communication of learnings is necessary.
