Safety Alert – SA286

Broken Strands under an 11kV Armour Rod

Date of issue: 06/01/2016

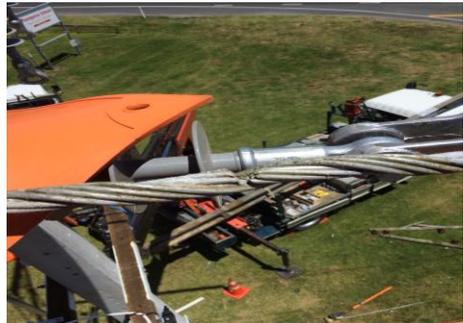
Incident	Description
<i>Date of Event</i>	21/12/15
<i>Location</i>	Old Coach Road, Paengaroa, Bay of Plenty
<i>Time</i>	11.30am
<i>Injuries/Damage sustained</i>	None
<i>Event Description</i>	<p>A crew were using glove and barrier methods to replace an 11kV pin pole for an ABS switch pole. They had secured and displaced the conductors and were removing the armour rods on one of the conductors when they observed that around half the conductor strands were broken under the armour rod.</p>

<i>Initial Actions Taken</i>	The crew reapplied the armour rods, secured the conductors with grips and strap hoist and then bridged across the armour rods using 11kV hoppers. Work was completed to plan and the incident reported to Northpower and PowerCo.
<i>Actions Required / Messages</i>	Remind all staff of the potential risk of damaged or broken conductor strands under armour rods, binder wire and connections which could cause the conductor to break when removed. Consider what control methods should be applied as part of the team brief and risk assessment process.
