Ref No: SIA 02-04

# Significant Incident Advice

# **Description Of Incident:**

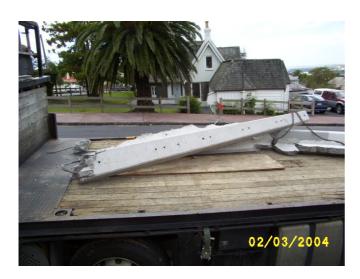
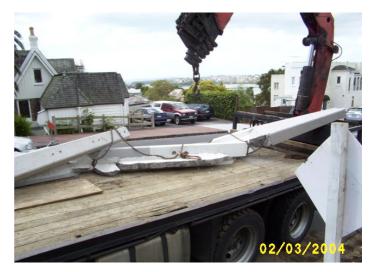
An 11 meter concrete pole (Busck type) broke in half whilst being unloaded from a delivery vehicle. **No injuries** were received by members of the workcrew or public.

A four person work crew were involved in the task of unloading two concrete poles from the deck of a delivery vehicle. A three metre long, two leg chain sling was attached to the swift lifts (imbedded lifting points). The first pole located on the footpath side of the delivery vehicle was unloaded and placed onto wooden support blocks located on the ground.

The second pole located on the drivers' side of the delivery vehicle was being lifted directly upwards in order to gain clearance over the top of the vehicle cabin when the centre of the pole between the chain swift lift attachment points disintegrated. This resulted in concrete being sprayed over the road and the pole sections contacting the ground.

An ENERGEX / Vector / Busck investigation is currently underway and the outcomes of the investigation will be communicated when they become available.

- The remains of the pole were loaded onto the delivery vehicle and transported to the supplier and quarantined.
- Pieces of concrete and debris were removed from the roadway.
- The site was made safe and the job cancelled.
- VECTOR issued a Safety Alert on Tuesday 2 March at 16.45 hours.

- All new concrete poles shall be visually inspected before being lifted for the following:
- 1. Any cracks.
- 2. Chips were steel reinforcement is exposed or chips were more than 50mm of concrete is missing.
- 3. Bending or bows greater than 100mm on any face over the entire length of the pole.
- 4. Any damage that may have been caused by forklifts or tie down chains.
- Concrete poles which do not pass the visual inspection criteria as specified between 1 and 4 are to be tagged or marked as being "Condemned", removed from service and the manufacture or supplier notified.
- In addition to the above
- 1. The <u>date of manufacture of all concrete</u> poles shall be noted on ENERGEX Form NZ-OH-FORM-002 "Work Activity Check sheet".
- 2. For Auckland, only Busck concrete poles supplied directly from Busck shall be used.
