## *Safety Advice 04-2012 (NZ)*

This Safety Advice outlines an incident and instructions issued internally by an asset owner following a Karabiner failure which is currently under investigation.

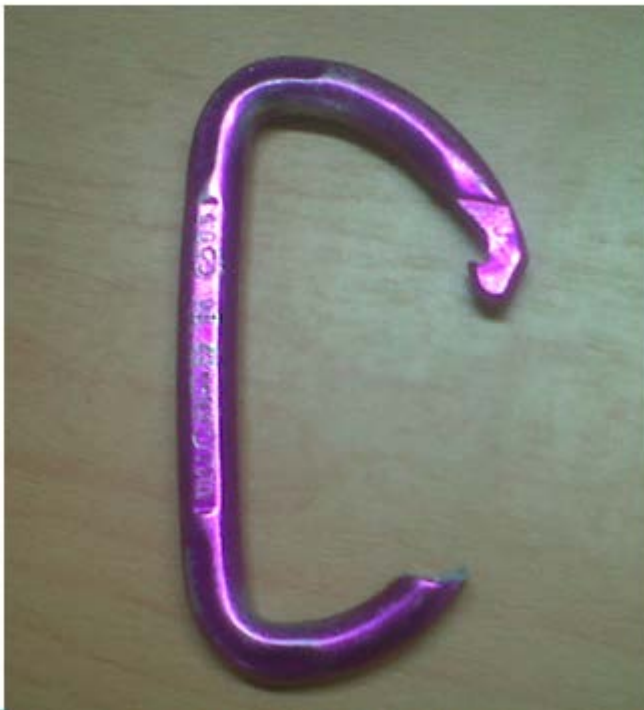
During a height safety training exercise an aluminium karabiner failed when load was applied. The karabiner may have been subject to 'cross-load', but was supporting the weight of a person wearing fall arrest equipment, stepping off a step ladder upper rung during a training exercise. The karabiner was considered to be well within its safe use limits, and the failure may have been attributable to metal failure through fine cracks sustained when it was dropped onto concrete from height.

PICTURE OF FAILED KARABINER

The asset owner banned the use of aluminium karabiners, opting for use of triple action steel karabiners at all of their sites, and required all aluminium karabiners to be destroyed. The internal instruction required the use of standard approved karabiner locking systems conforming to AS/NZS 1891.
