## *Safety Advice 04-2013 (Apr)(NZ)*

# safety alert

## Tower Assembly

E11132

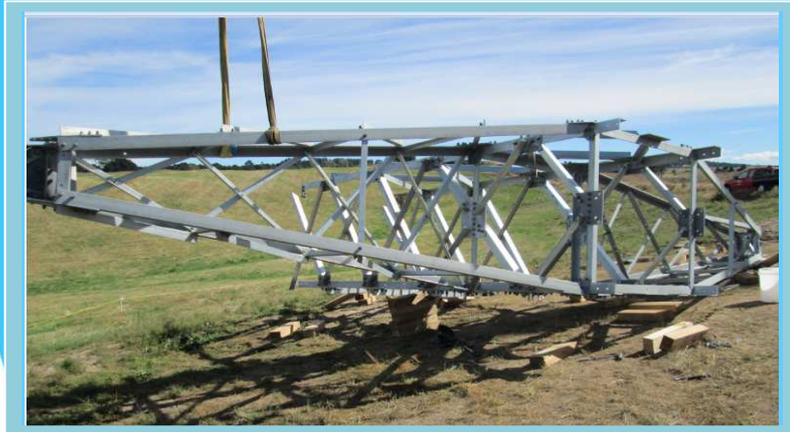
Sprained ligament.

While assembling a tower crossarm on uneven ground (supported on dunnage). A crane was used to lift the crossarm to align the bolt holes. During the lift the dunnage moved sideways causing the steel to slide onto a line mechanic's right ankle which resulted in a sprained ligament. The line mechanic was tightening bolts on the assembly at the time of the event.

Job was stopped, Construction Manager was notified.  
Hold point briefing conducted.  
Line mechanic was taken to hospital for examination  
Best practices for lifting loads discussed with team, guidelines issued to all tower crews.
