Safety Advice 06-2004 (NZ)

NEAR MISS INCIDENT - CABLE CUTTING

Cable cut whilst live pilot inside.

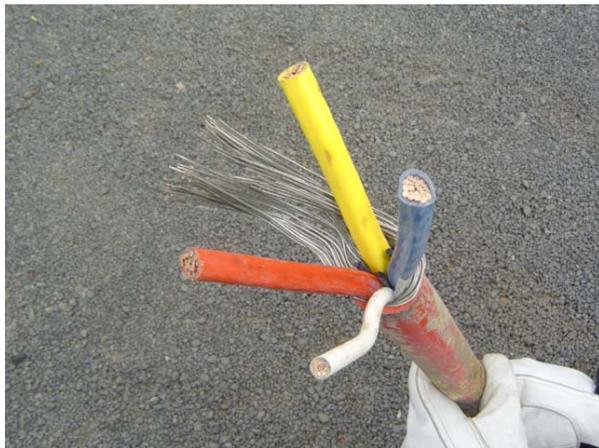
The pilot was a white 10mm² core at the source end underground box and had been joined to a piece of red 6mm² conduit wire at the load end underground box. The proximity detector did not detect this cable when used in the load end underground box. The pilot was isolated and further testing carried out to determine that all cables were now isolated and the job completed.

1. Use spiking gun.
2. Do not rely on proximity detectors to guarantee screened underground cables have been isolated. The pilot was on the bottom of the cable where the cut was made. The pilot location plus the cable screen may have been the cause of the proximity detector failing to detect the live pilot.
3. This type of cable, three phase plus pilot, is not common within the network and may have been a factor in the incident.

Neutral screen cable + pilot.

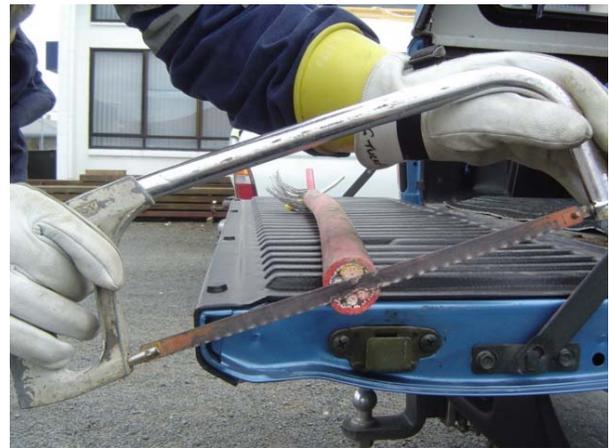
The blade of the hacksaw was approximately three-quarters of the way through the cable when there was a loud pop heard from the cable. There was no flash from the cable when the live pilot was hit by the hacksaw.

Approximate depth of hacksaw when LIVE pilot was hit.

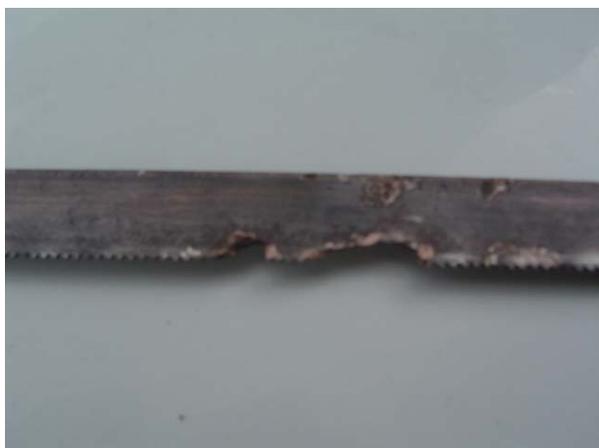
There were no injuries to any personnel. The only equipment damage was to the hacksaw blade as the photographs indicate.

Hacksaw blade.
