Safety Advice 07-2006 (NZ)

June 2006 – Electric Shock While Tree Trimming

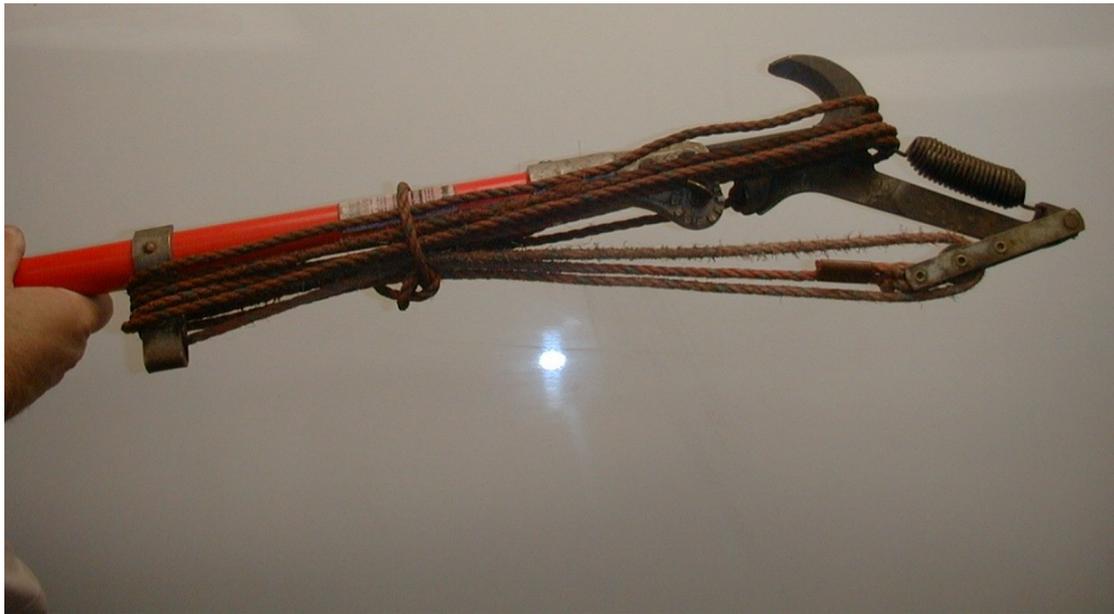
Fig 1: Chance insulated lopper

Inquiries indicated that the required tests for the stick set were current, but that the testing organisation tests did not cover the insulated tool actuating rope component. Post-incident, the tool actuating rope was meggered as presented straight from the kit. The rope had a strong smell of pine sap. A 5kV megger gave a result of 500 Gig ohm. The rope was then saturated with water. The test was now around 4 megohm. At 6350 volts to earth, a leakage current of around 1.5 ma would have flowed when connected from line to earth -enough to cause an electric shock but of small enough current so the insulated tool actuating rope could be let go.

- Both team members believed that the insulated lopper rope, being part of the insulated tool subject to the equipment testing regime, had been tested and was suitable for this use.

- Selection and observance of correct procedures for the required task and that employees understand the scope and limitations of these;
- Employees understand the correct description of each tool and limitations on use, particularly in terms of electrical insulation properties and suitability for use in dealing with trees in contact with live lines. Use of incorrect tools also involves greater risk of electrical harm especially where access is through layers of other in-service pole-mounted circuits;
- Ensure testing organisations test all tool components required by appropriate standards and manufacturer’s instructions; and
