Safety Advice 08-2012 (March)(NZ)

Scaffold Tube Failure

HSSE 19147 – High Potential Near Hit

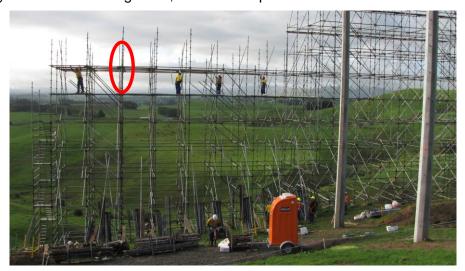
A scaffold contractor was installing a piece of scaffold tube at the top of a section of scaffolding when the tube he was attached to (via safety harness and lanyard), broke as he leant back to step down.

As he started to fall backwards, he was grabbed by a co worker, preventing him from falling. The scaffolder was approximately 22 metres off the ground, as shown in photo below.

Scaffold depicting position of scaffolder at time of incident

A Safety meeting held with all site personnel to discuss the seriousness of such an event.

All equipment was inspected to ensure no other defective equipment was on site, and a review was initiated of all erected scaffold to check for any defects that may have been previously missed.

All equipment must be thoroughly inspected before installing.

Operatives to ensure they are attached to a secure part of the structure at all times.
