Safety Advice 09-2009 (NZ)

Arc Flash Burns During Visual Inspection of In-Service 11kV Circuit Breaker

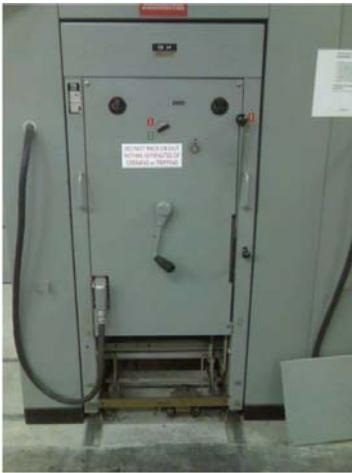
- The decision to remove a panel off the Circuit Breaker whilst in service with the intention of exposing live High Voltage was a poor one, considering that it was entirely possible to isolate the circuit breaker prior.
- The CB was returned to service without clear communication between the work party supervisor and the Maintenance Switcher.
- The most probable cause of the arc 'flash over' was an inadvertent breach of the MAD by the Maintenance Switcher's hand whilst manoeuvring into position to undertake the visual inspection.

Circuit Breaker racked in (*with lower panel removed*)

- Implement work procedures surrounding equipment that is under repair (irrespective of whether it is covered by an Access Permit), to ensure that it is not returned to service prematurely.
- Forbid the removal of any panels/covers from in service switchgear that requires the use of a tool (designed to prevent access during the normal course of operations).

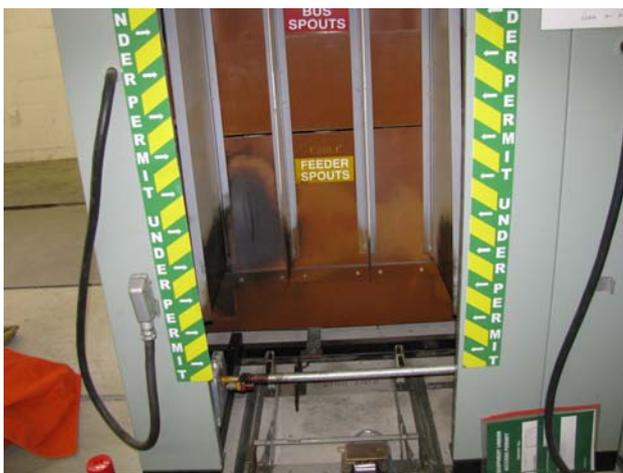
Whilst carrying out this inspection, there was a flashover in the CB compartment resulting in flash burn injuries to the Maintenance Switcher. The Buszone protection operated and cleared the 10,000 amp fault in 80 milli-seconds.

Circuit Breaker cubicle. (*Note arc flash marks to busbar shutters at left-hand side of cubicle – left-hand side module was the module that was suspected to be leaking oil*)

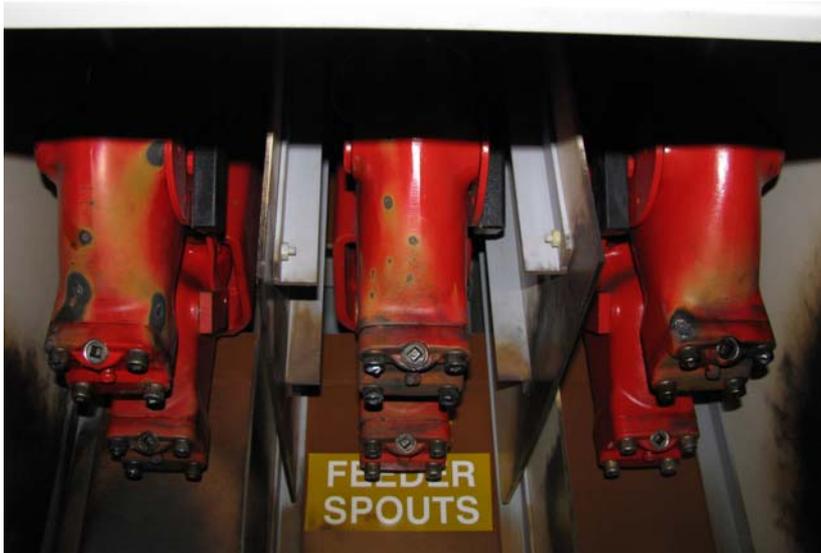
The members of the work party (including the Maintenance Switcher) were aware that by removing the panel it would expose live high voltage switchgear but were confident that they would be outside the Minimum Approach Distance (MAD) for 11kv (300mm) providing the inspection was for **visual purposes only**.

Circuit Breaker phase modules as viewed when lower panel removed
(Note that when racked in and in-service the phase modules are live)
