11kV SWER Line Incident – Hazardous Electrical Condition

Bulletin No: 011
NOE Ref: N/A
Issue: Version 1.0 – 07.05.12
Issued By: Safety and Training Manager
Number of Pages: 2

INCIDENT – HAZARDOUS ELECTRICAL CONDITION AT QUAIL DOWNS FARM

3429 INLAND KAIKOURA ROAD, STAG AND SPEY, NORTH CANTERBURY

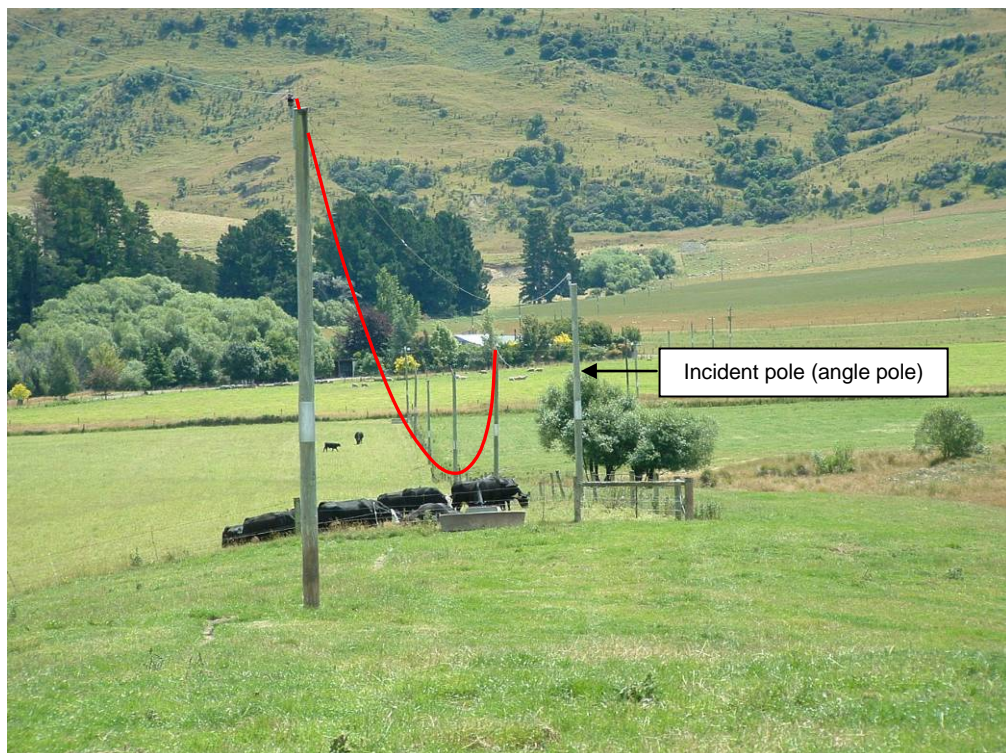
On Saturday 28 January 2012, a fault on the MainPower 11 kV single wire earth-return (SWER) line running through Quail Downs farm, caused a pole top fire and resulted in the SWER conductor detaching from an angle pole, spanning two adjacent poles, and suspended at 1.2 – 1.5 metres above ground level at its lowest point. The SWER conductor remained live at a potential difference of 11 kV to earth presenting a hazardous electrical condition to people and livestock.

- (a) MainPower believes that the cause of the fault that resulted in the SWER conductor falling from the angle pole was a bird contact between the live 11 kV SWER conductor and the CCA treated softwood pole, causing arcing which ignited the pole. The pole top burnt away to the extent that the two pole top insulator brackets, together with mounting bolts, insulators and SWER conductor, separated from the pole top.

- (b) The causal factors of the hazardous electrical condition were the combination of the following:
 - (i) clearance between the 11 kV SWER conductor and the nearest uninsulated part of the pole or attachment, was able to be bridged by a bird, and

- (ii) pole was relatively flammable, and
 - (iii) pole arrangement (angle pole), and
 - (iv) undulating hill incline terrain.
- (c) The incidence of pole fires on the 11 kV SWER line systems is high when compared to the number of pole fires on 11 kV and 22 kV lines, relative to the respective total installed line lengths. MainPower believes SWER line pole fires appear to have all occurred on CCA treated pine poles with single or double pole top insulator brackets.

- (d) The pole top insulator bracket has been redesigned with increased clearances from live parts to the nearest uninsulated part of the pole or attachment, to minimise the risk of a wildlife induced pole fire. The clearance distance has been increased from approximately 250 mm in the previous design, to 505 mm in the redesign.

- (e) The Inland Kaikoura Road SWER line has been surveyed, maintenance plans produced, and construction work commenced on installation of the redesigned pole top insulator bracket.
