## Event Notice - Defective Manufacture

### Magnefix Switching Unit Failed Tests

January 2017

Orion

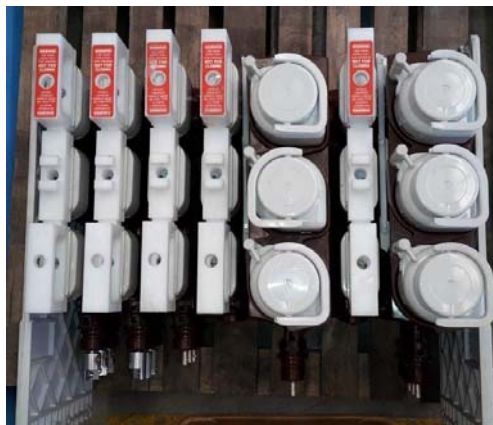
During the commissioning process which included continuity testing it was found that there appeared to be a connection between switches of the fused ways that should not be there.

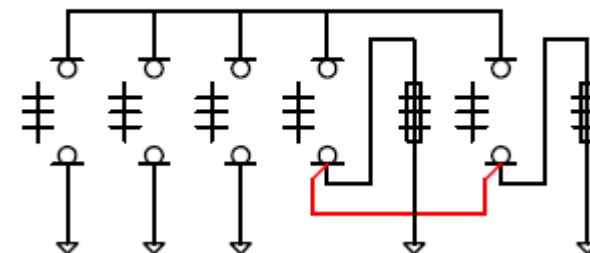
3K2T SLD

Further testing in our workshop has found that this MSU has been manufactured incorrectly with an internal connection between the load side of the switches on both fused units (shown on SLD in red). This defect would mean that livening of one transformer could also liven the second transformer if fuses have been installed in the second unit. Removing the switches of one unit does not necessarily de-energise either transformer.

When commissioning, complete testing is required to ensure the MSU has been correctly manufactured. Continuity tests across poles referenced to the manufacturers single line diagram can prove this.

When energising and de-energising previously commissioned MSU's, testing to prove de-energised must be completed on the load side of the switch associated with the fused way prior to the removal of fuses. If energised, seek further advice
