## *Safety Advice 10-2013 (Apr)(NZ)*

This Safety Alert 10-2013 (Apr) (NZ), dated 22.4.13 from Transpower, outlines an incident where a small rock fell from a digger bucket breaking a gas pipeline.

## Falling rock damages gas pipeline

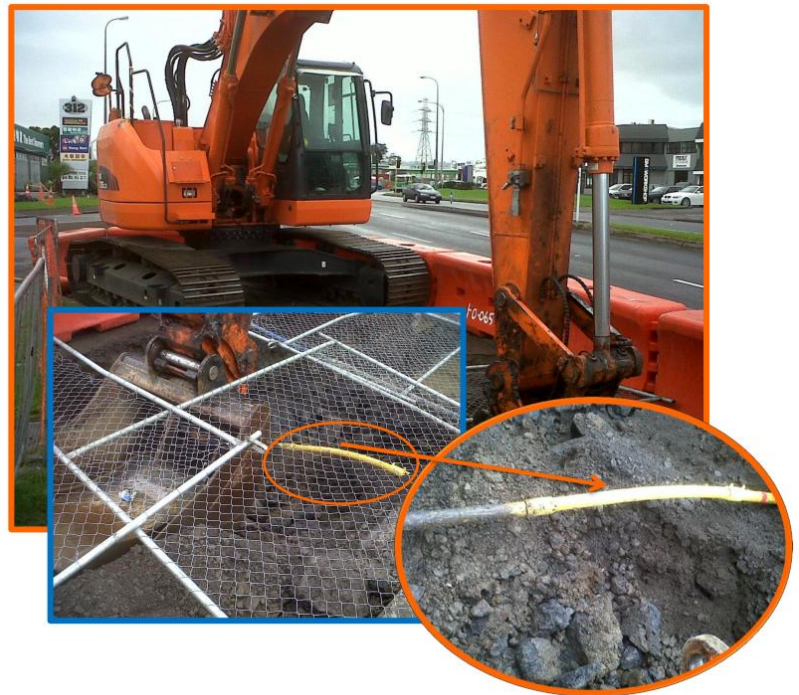
During the night shift on 22/04/2013 rock was being removed from a trench with a 22 tonne digger and was being loaded on to a truck at Ti Rakau Drive.

A rock fell out of the excavator bucket, striking a gas pipeline (65mm yellow plastic conduit). The velocity and weight (the drop was approximately 3.2 metres) of the rock created a pin hole in the line.

The gas pipe was known to the excavation gang and was fully exposed at time of incident.

- Emergency Services (Fire and Police) were called.
- Owners of the pipeline (Vector) were called, the supply was switched off and the pipeline was repaired.
- An Exclusive Safety Zone was erected around the area by NZ Fire Services Work.
- **Ensure that buckets are not over-filled when removing material adjacent to services and/or lifting over services.**
- **Place protective covers over services when working over them.**
