TRANSPOWER

FIRST ALERT

Broken Climbing System discovered

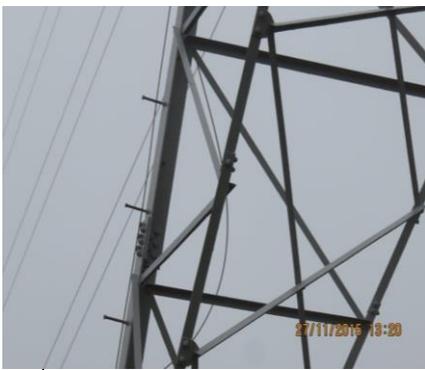
Broadspectrum (Transfield) Linestaff were patrolling the BPE WIL A line on Friday 29th November. When they arrived at Tower 341 (on a very exposed ridge just out from Wilton Substation) they found the Climbing System cable broken and wrapped around the tower leg. A 3m section still remained attached to the top of the tower. Fortunately there was no contact between the cable (stainless steel) and the adjacent circuits and no public safety issues. Weather conditions at the time consisted of low visibility and strong winds.

- The cable was removed from the tower and site made safe.
- Line staff informed their manager of the situation. A climbing inspection of other exposed sites around Wellington with similar systems installed will be completed over the next few days.
- An investigation is underway to determine the root cause of this failure. Once this report is completed, Transpower will review the climbing system. **Until this report is made available, similar climbing systems are not to be installed or used as a fall arrest system on Transpower assets. This requirement is effective immediately.**
- If staff are working on a structure with such a climbing system installed, it is to be inspected and findings reported to John A Wilson of Transpower (details are below).
