# Uncontrolled Release of Pole (FA081)

*Moderate  
Critical Risk: Falling Object*

Incident	Description	
<b>Event Date:</b> 15/11/2024	<b>Time:</b> 16:00 hrs	<b>Location:</b> Arapuni-Hamilton-A0263
<b>Investigation Status:</b>	<b>On-going</b>	<b>NP Reference:</b> OCC14661 / INV1691 <b>Maximo:</b> 176448

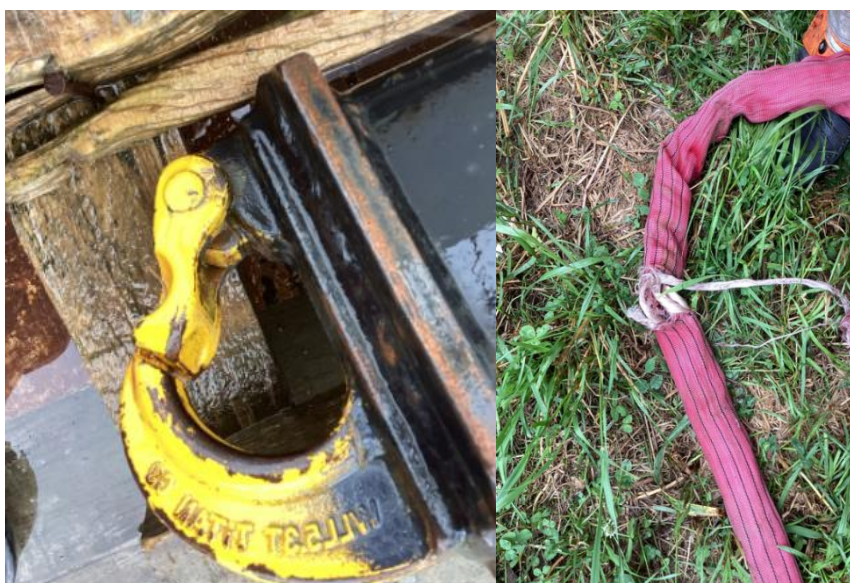
On Friday 15<sup>th</sup> November 2024, a Northpower transmission lines team replaced a single Pole structure on the Arapuni – Hamilton – A-line. As the old pole was being lowered to the ground, the sling was damaged and became dislodged from the fixed Hiab hook, at this point the base of the pole was on the ground and the top of the pole was nearing a horizontal position, approximately 3-4m off the ground. All personnel on site were in a clear safe zone, outside the identified drop zone when the incident occurred.

Ensure drop zones are established and managed in accordance with the drop zone procedure whenever there is potential for objects to fall.

Rated chains should be used to remove wooden poles to eliminate the potential of a sling being damaged.
