# FIRST ALERT

BZ Trip isolate switch left selected to isolate for an extended period of time

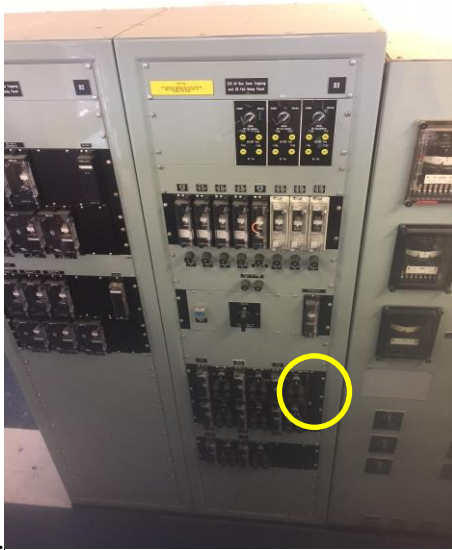
It was identified that the Trip-Isolate switch for CB 642 on panel D3 was in the isolate position. Yellow circle indicates the location.

With the absence of any notice or isolation tape on the switch, further investigations discovered it should have been selected to service.

The switch was returned to service via a switching sequence.

- The Project Manager notified the NS7 Service Delivery Manager (SDM).
- The switch was selected to service.
- The station log indicates the last time it was operated via a Transpower operating sequence would have been June 2015.
- The trip isolate switch is mounted low on the panel and is not easily identified during a station inspection. SMP SI0011 section 16 requires all protection switches be checked, but was one of the last line items for the section. Given the operational importance of these checks the SMP has been edited to have the protection switches to be the first of the check items for Section 16.
- Send out a first alert highlighting the importance of checking protection switches while undertaking station inspections.
