## Earth switch contact fell to ground during switching

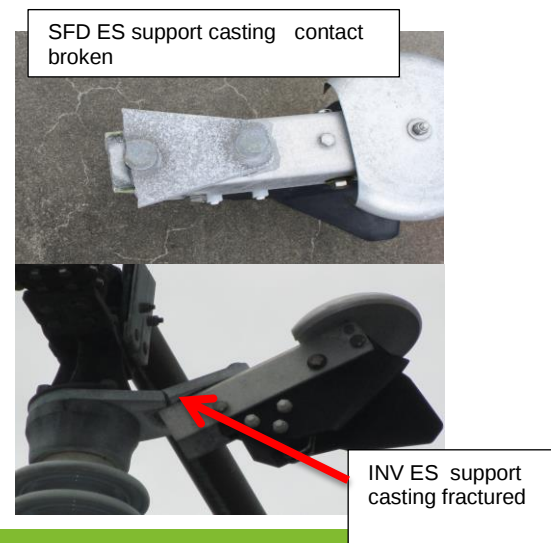
An operational near miss happened when an earth switch contact fell to the ground during switching at Stratford (SFD) on the 17<sup>th</sup> of November 2015 at 9:30am. The switcher was operating SFD-ES-529 when the yellow phase fixed contact broke and fell to the ground. Fortunately the switcher was standing underneath the red phase. If the red phase contact had dropped, he could have been severely hurt.

The bottom image to the right shows another earth switch at Invercargill (INV) where a similar contact has failed but has not yet broken off completely.

- The cause of the failure is believed to be defects in the manufacture of the support casting holding the earth switch fixed contact.

- All 20 sites having the Hapam AM 245 type earth switch have been identified.
- Instructions have been issued for Warning Signs labelled “**Do Not Operate**” to be put up on temporary hazard boards at all sites that have this Hapam AM 245 type of earth switch.
- Visual inspection should be reinforced prior to operation of disconnectors that are mounted with these earth switches.
- Transpower is working with the manufacturer to seek additional information and support.
